PROJECT GEMINI

A Technical Summary

by P. W. Malik and G. A. Souris

Prepared by
MCDONNELL DOUGLAS CORPORATION
St. Louis, Mo.

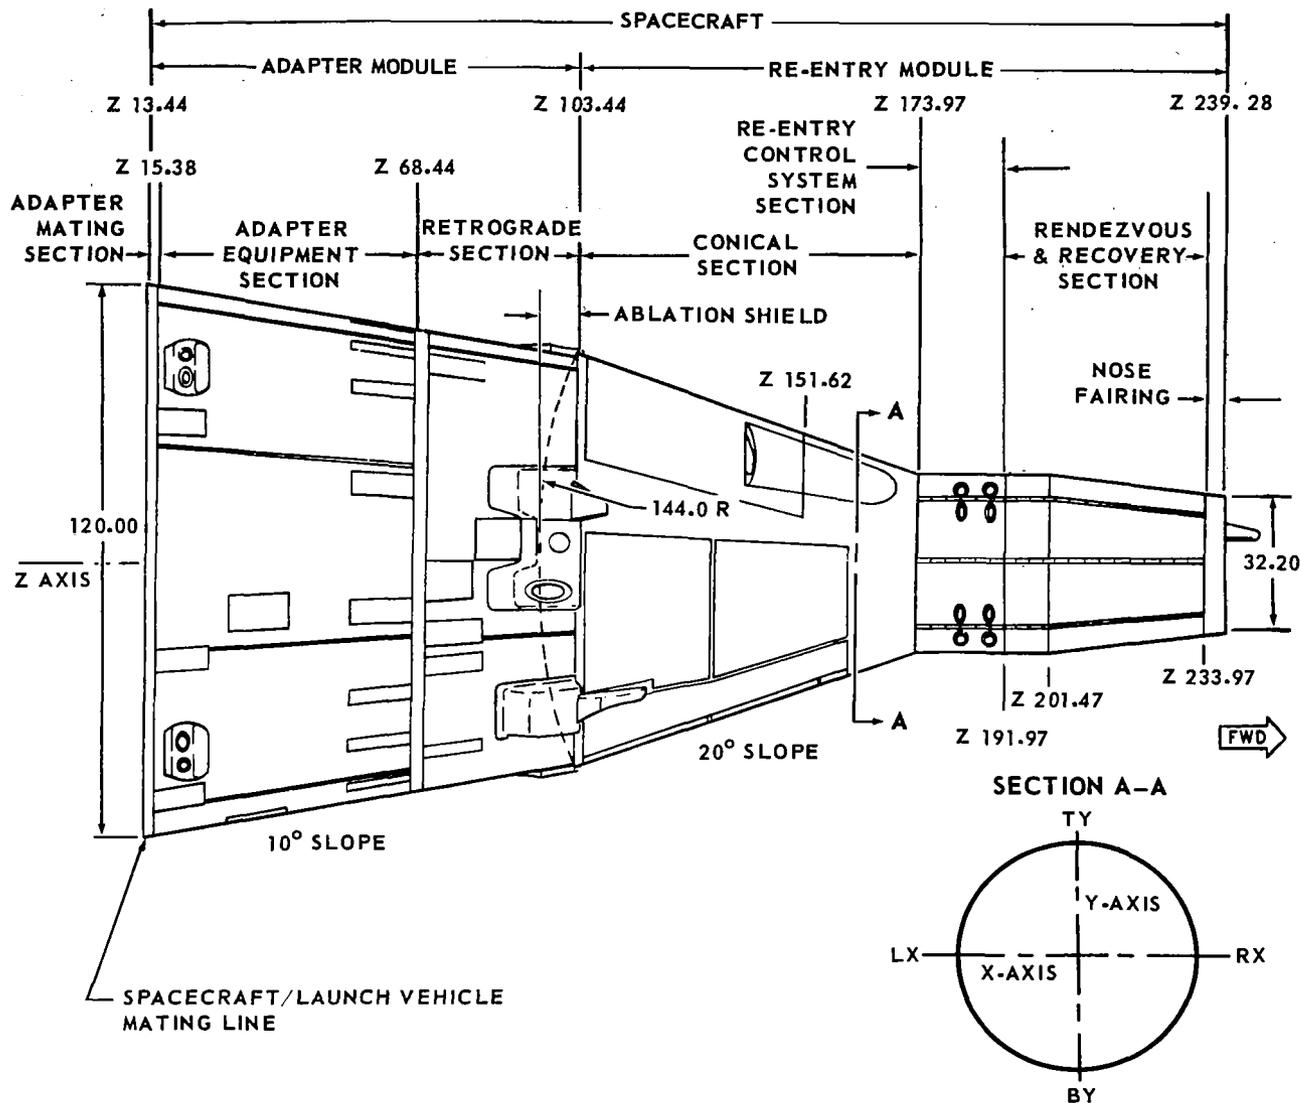
FIGURE 1 SPACECRAFT GENERAL ARRANGEMENT

The Gemini Spacecraft, designed to provide life support for two orbiting astronauts, is a 7000 lb conical structure 18.82 ft long and 10 ft in diameter at its base. It is composed of two major assemblies, a re-entry module and an adapter module. Both structural bodies are all metal, of stressed skin and semimonocoque construction. In addition, the re-entry module is designed to withstand the extreme heat of re-entry. The general arrangement of the Gemini Spacecraft is shown in Fig. 1.

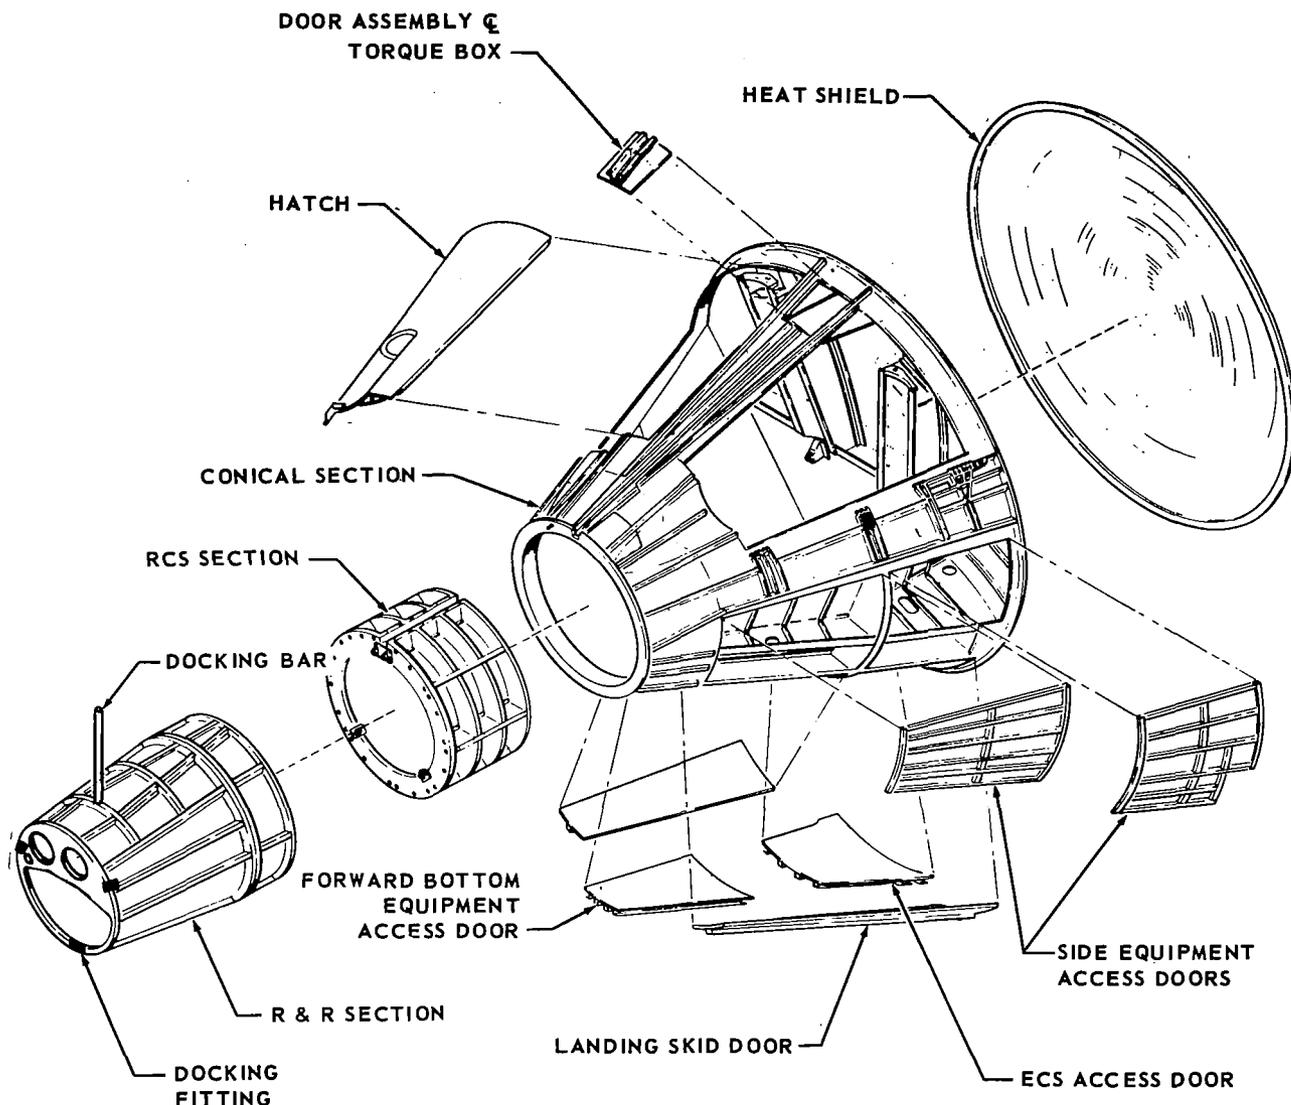
FIGURE 2 RE-ENTRY MODULE STRUCTURE

Re-entry Control System Section. - The RCS section is contained between the R & R section and the cabin section. This cylindrical section houses re-entry control system fuel and oxidizer tanks, and thrust chamber assemblies. In addition to accommodating the re-entry control system, which controls the spacecraft after the orbit attitude and maneuver system (OAMS) has been jettisoned, the RCS section also absorbs the loads induced by the deployment

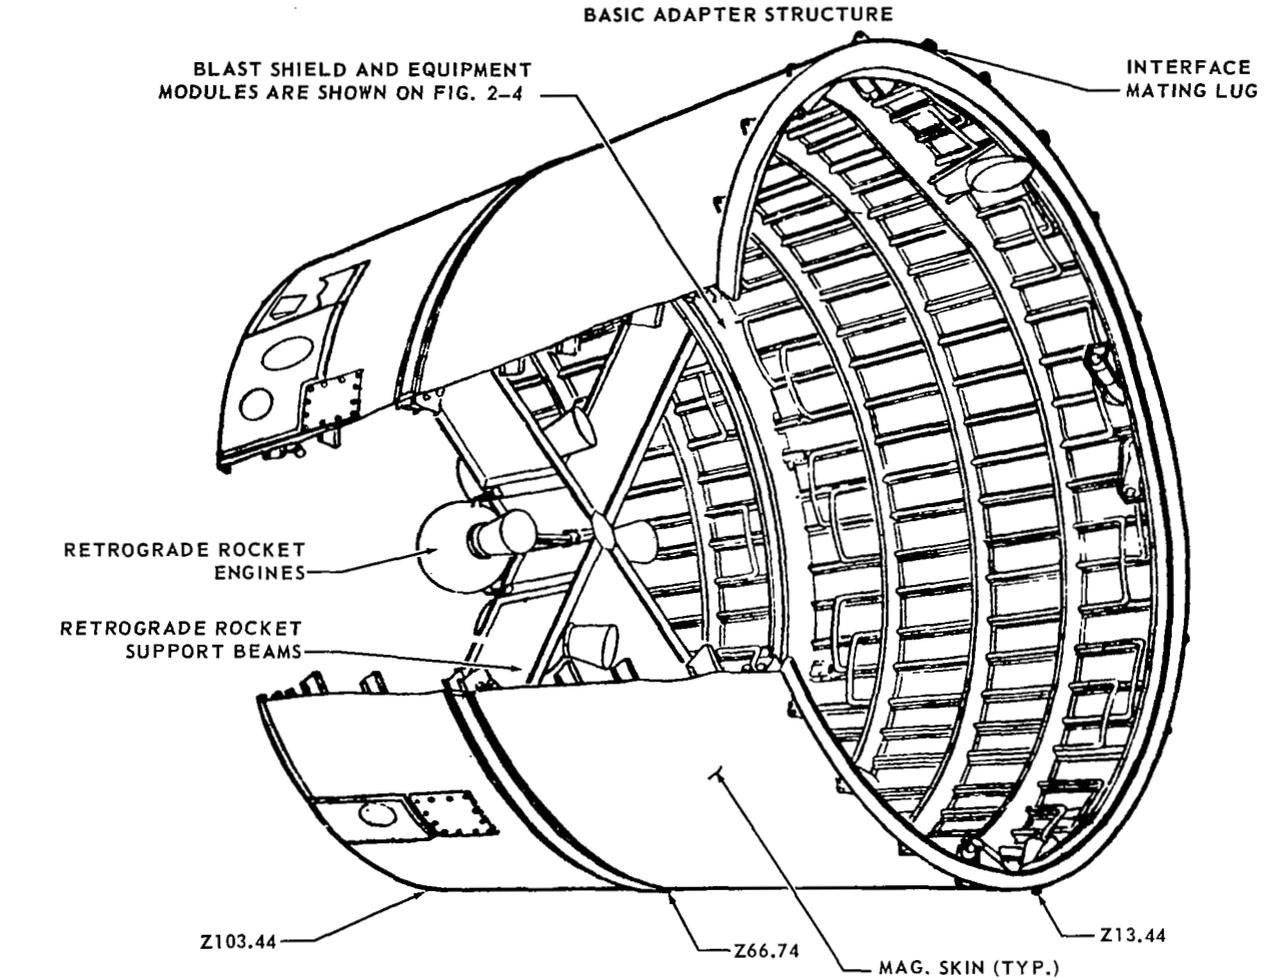
STRAP LOCATIONS
AT Z103.44
LOOKING FORWARD

The adapter is joined to the re-entry module by three titanium retaining straps external to the structure of both the re-entry module and the adapter section. Pyrotechnic separation rings are provided between the retrograde and the equipment sections, and between the equipment and the launch-vehicle mating sections.

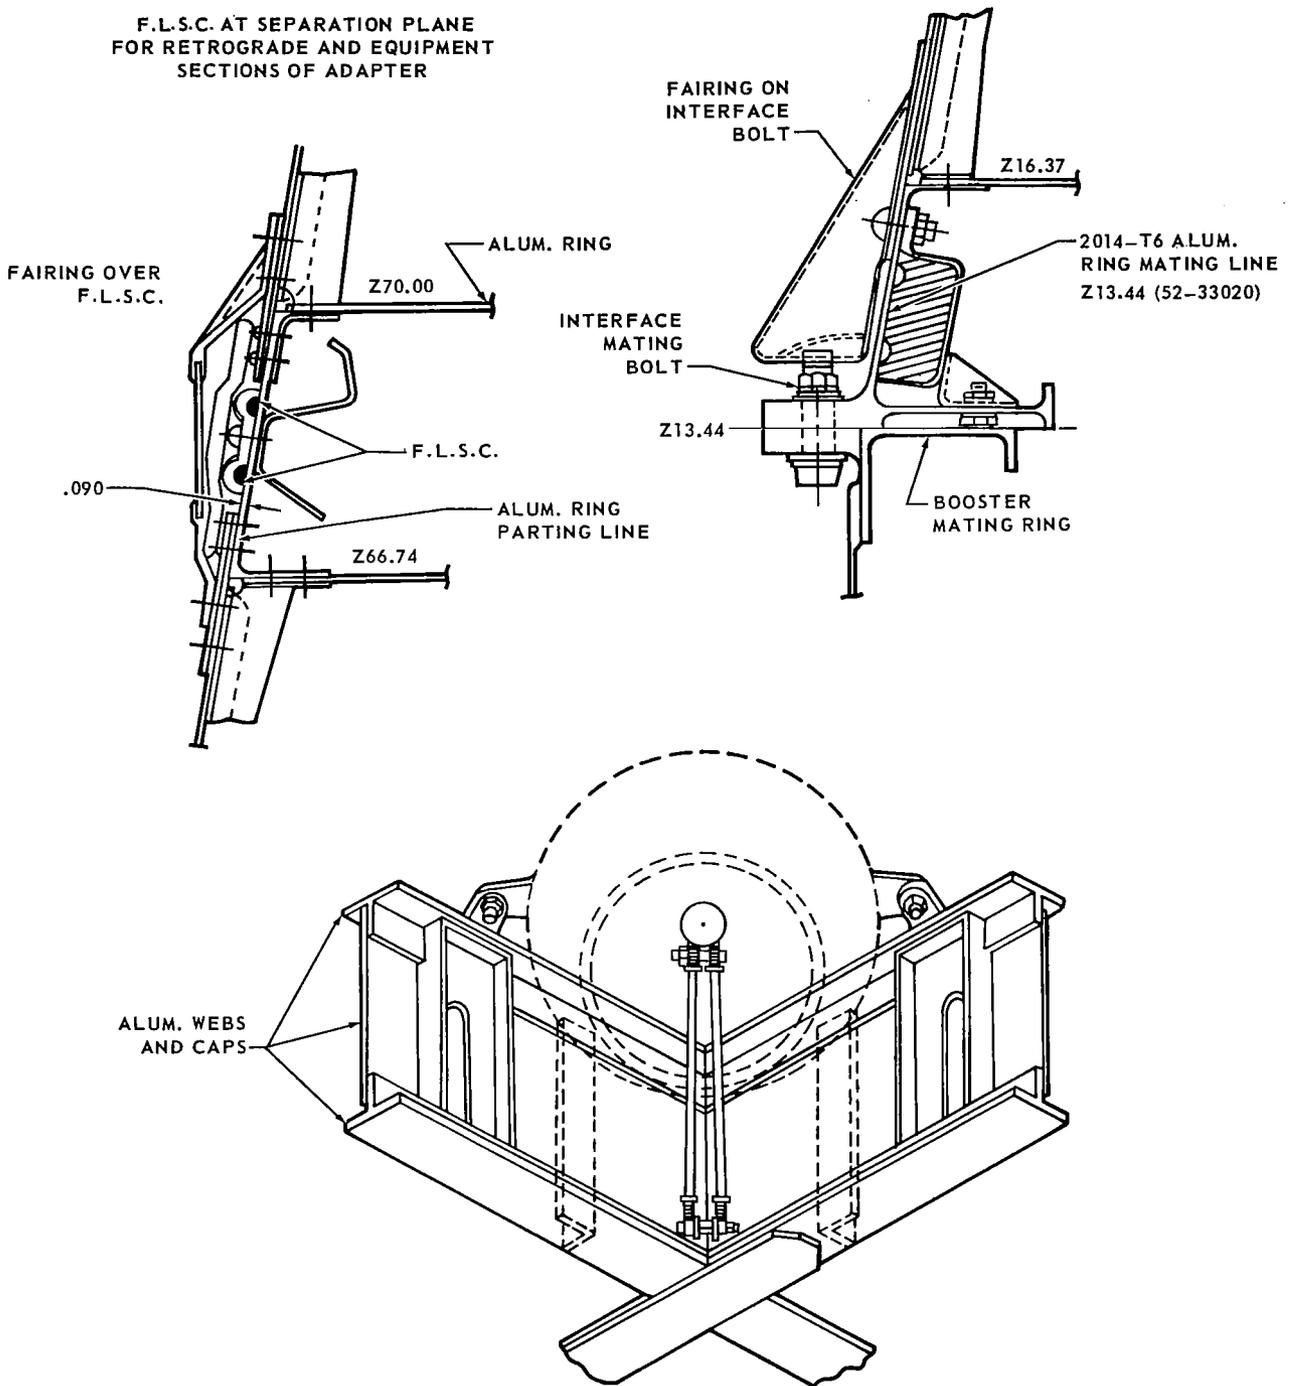
FIGURE 3 ADAPTER STRUCTURE (Continued)

F.L.S.C. AT SEPARATION PLANE
FOR RETROGRADE AND EQUIPMENT
SECTIONS OF ADAPTER

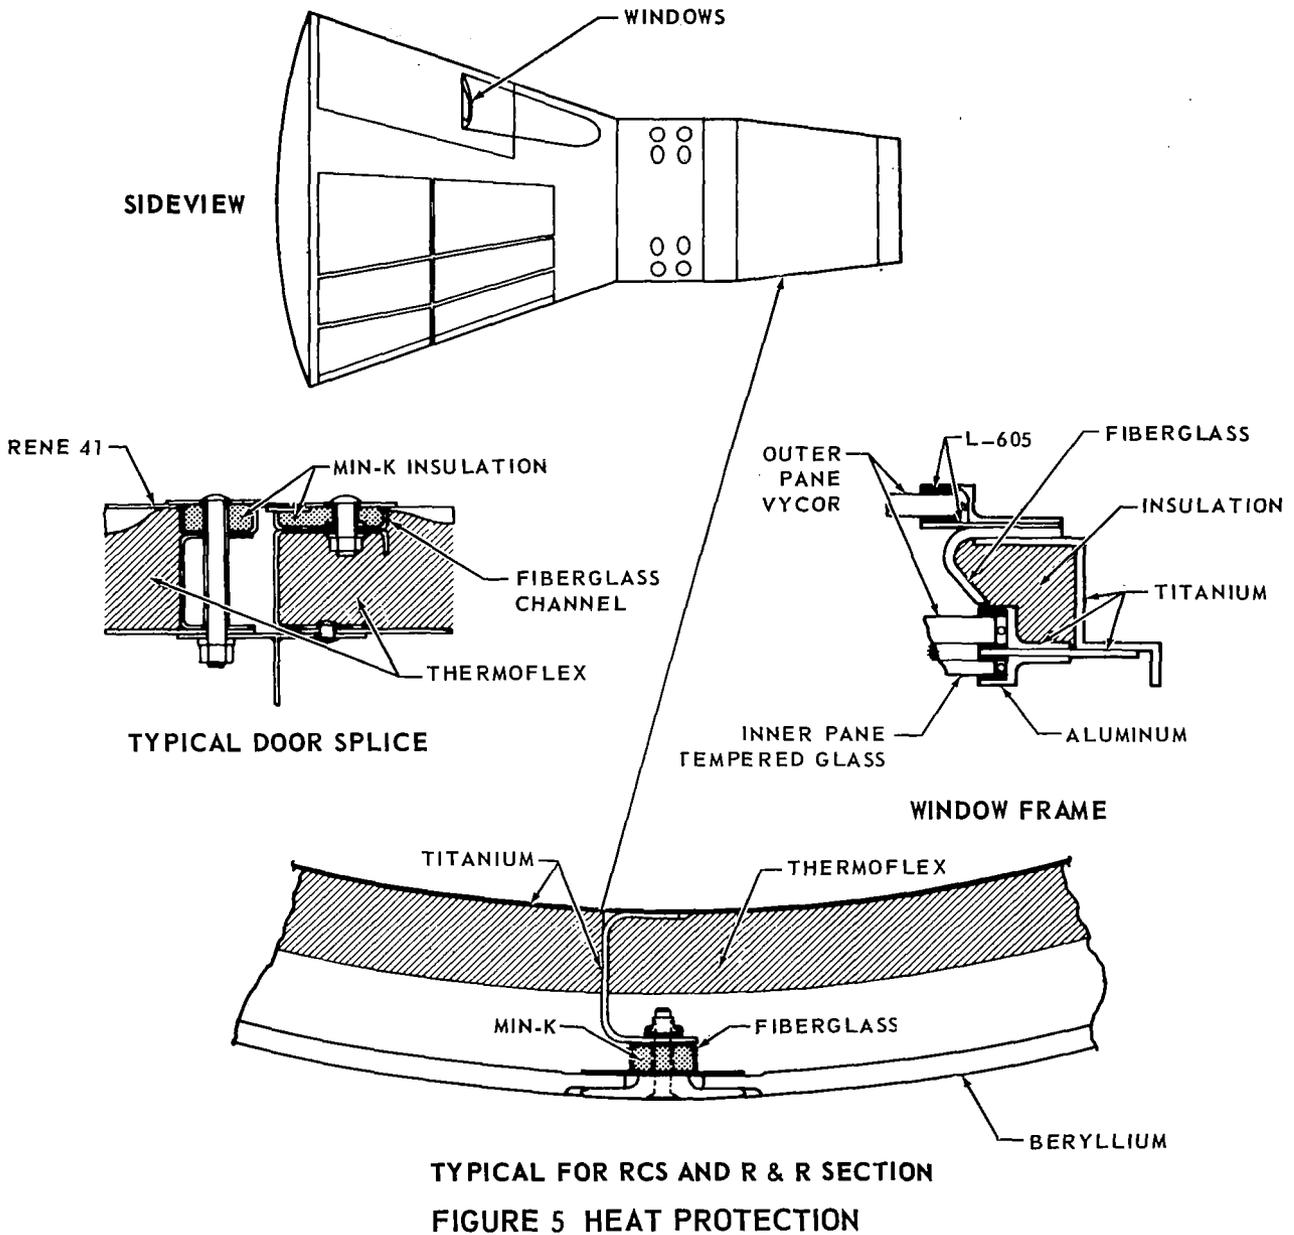
the adapter module is coated with white ceramic paint and the inner surface is covered with aluminum foil to reduce emissivity. The heat protection devices are pictured in Fig. 5.

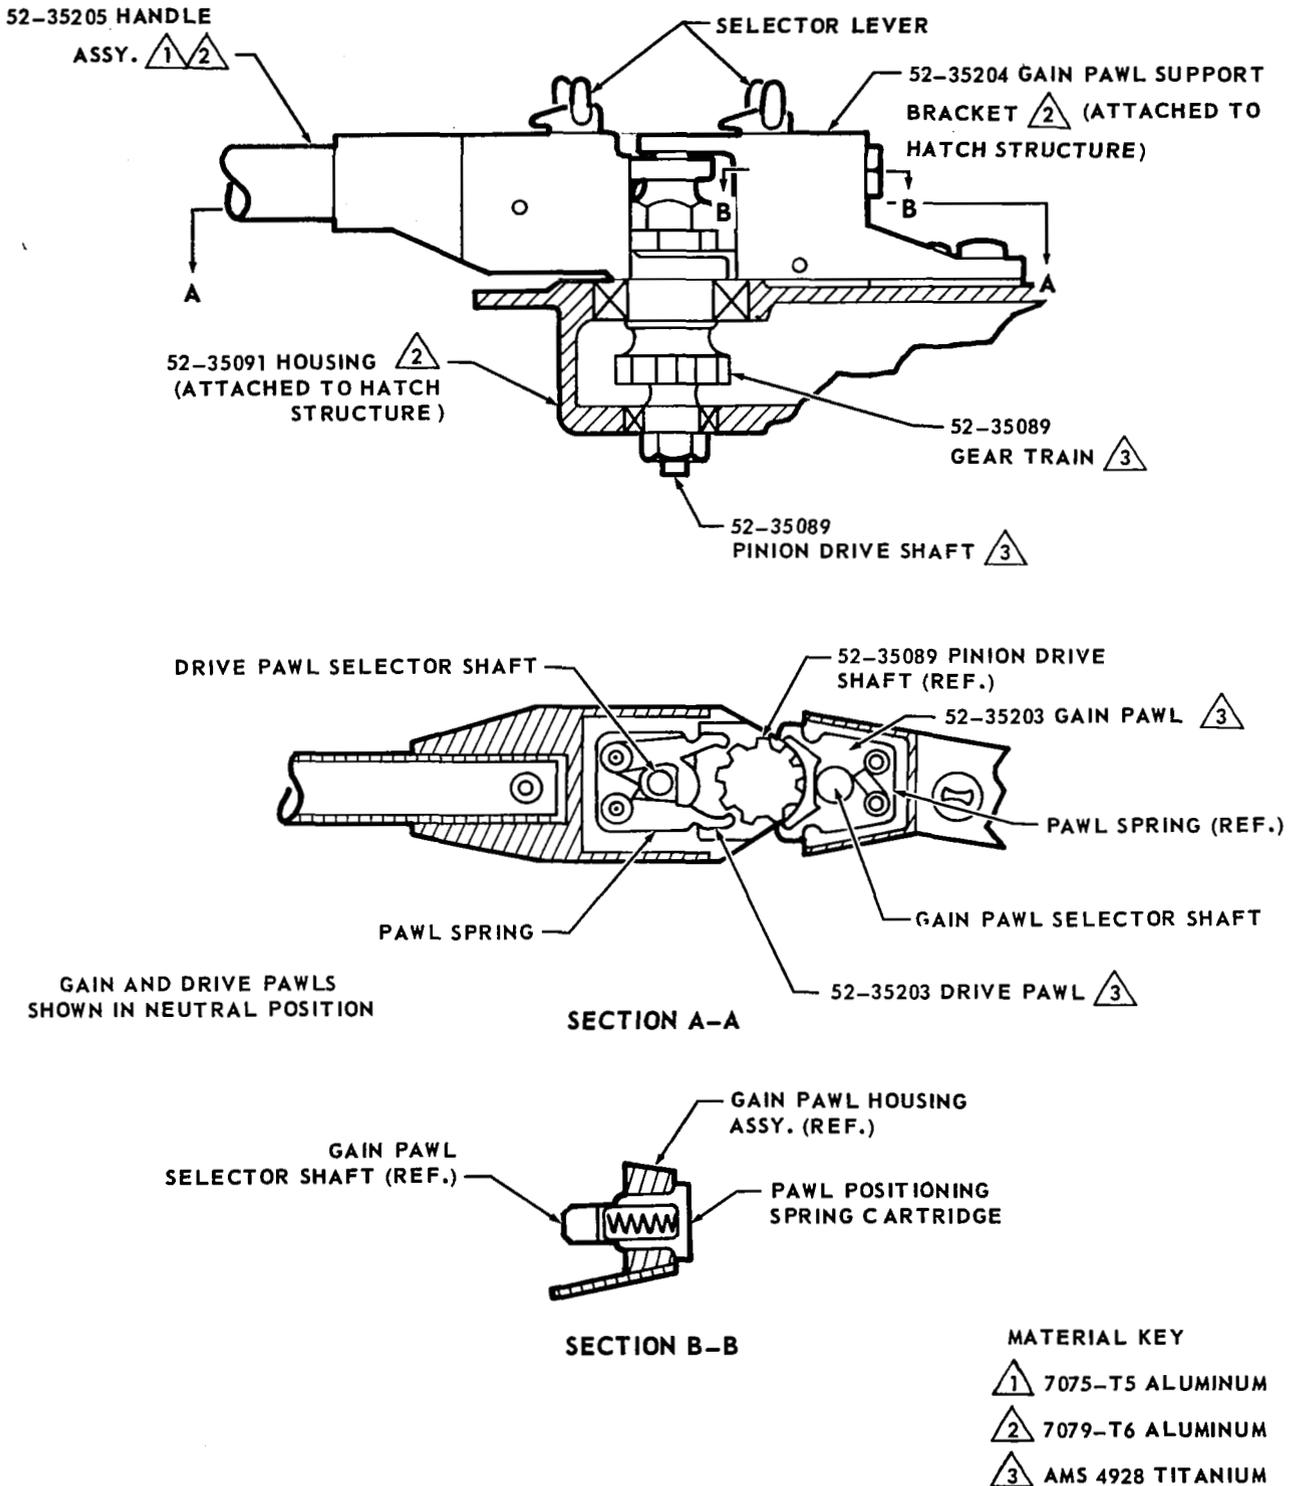
FIGURE 6 HATCH MANUAL CONTROL MECHANISM

No structural failures occurred during development or qualification testing. However, a change was incorporated in Spacecraft 6 and up as the result of an anomaly on Gemini IV in the hatch manual control mechanism. This mechanism change is illustrated in Fig. 6. The pinion drive shaft, which works the hatch latch linkages when the manual handle is operated, is driven by engagement of drive and gain pawls in a ratchet configuration. The automatic return of drive and gain pawls failed to operate positively due to frictional effects. This necessitated manual operation of the selector in Gemini IV. The efficiency of this mechanism has been greatly increased by reducing frictional effects and by increasing the return mechanical advantage by a factor of 10.

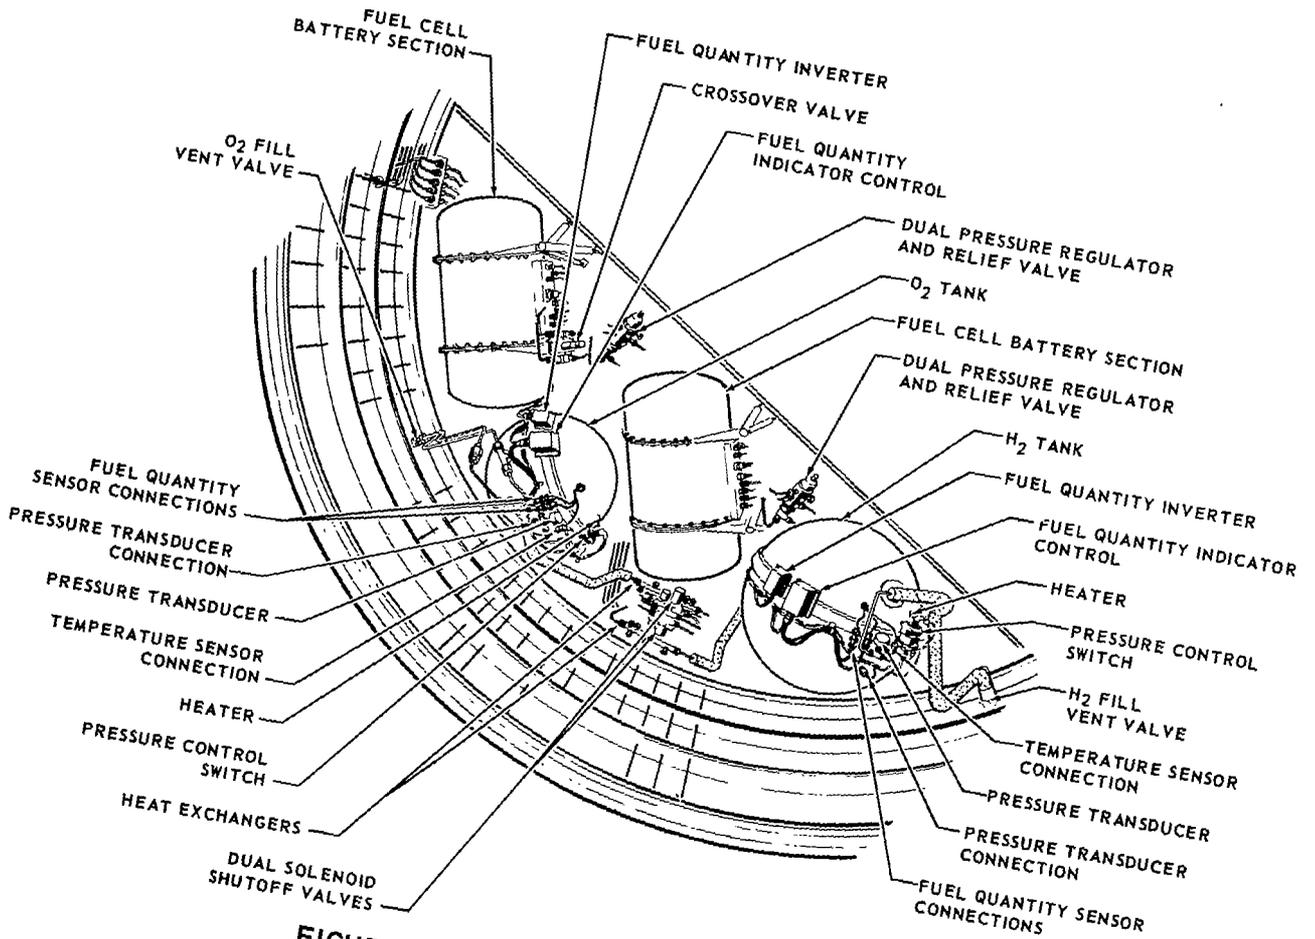
FIGURE 7 RSS/FUEL CELL MODULE

The water created by the fuel cell must be removed as the reaction continues. The pressure in the oxygen cavity in the fuel cell (approximately 22.2 psi) is used to drive the water through the porous sintered glass separator plates into the water collection basins beneath the cell. The pressure in these basins is maintained at about 20 psi and regulated by an ECS pressure regulator.

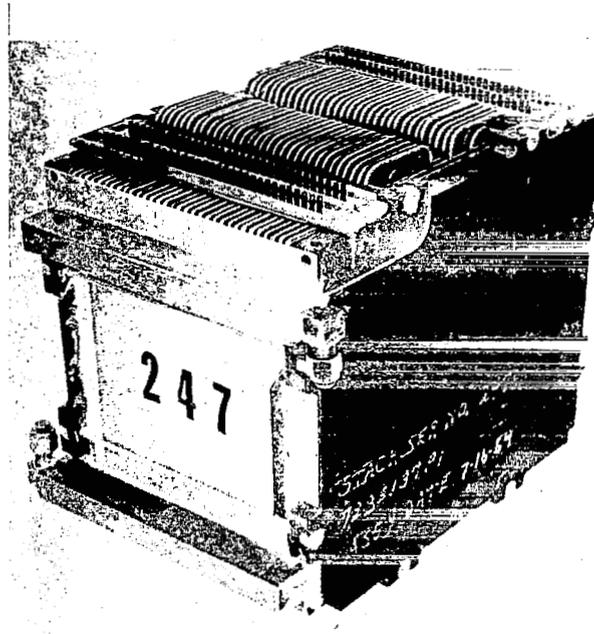
Qualification testing of the P2B cell design included vibration, acceleration and shock tests. The P2B test sections were successfully tested under the conditions producing an electrical load consistent with Gemini mission requirements.

FUEL CELL STACK CONTAINING INDIVIDUAL FUEL CELL ASSEMBLIES

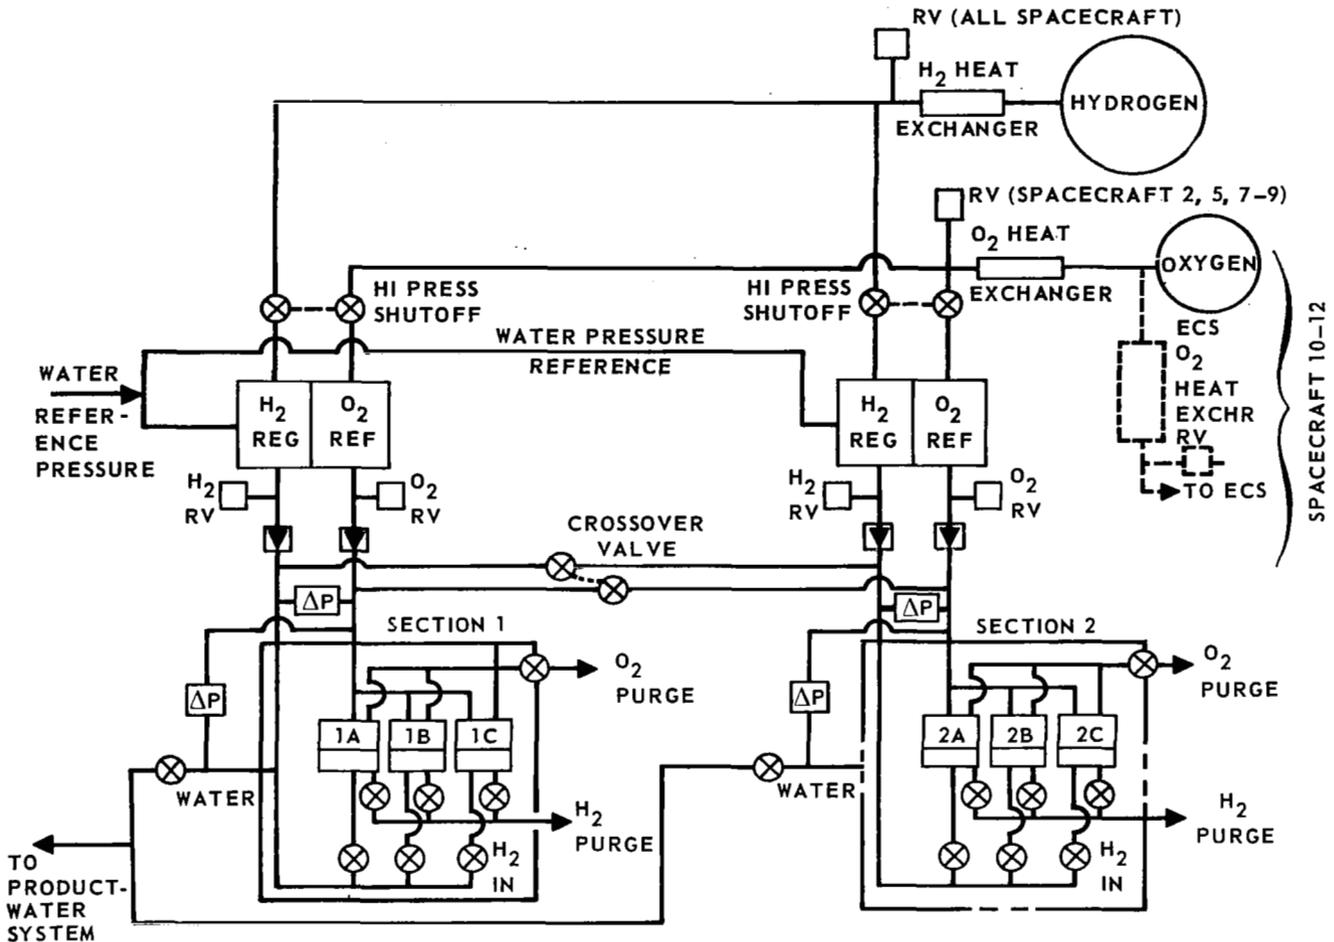
FIGURE 9 FUEL CELL RSS SCHEMATIC

The system senses the generation of product water, and permits sufficient reactant flow to the fuel cell cavity to maintain a constant pressure on the porous glass separator plates above the water basins. (Ref Fuel Cell Technology, page 51.) Product water pressure is maintained at approximately 20 psi. Hydrogen pressure is reduced to approximately 21.7 psi for delivery to the fuel cell; oxygen pressure is reduced to approximately 22.2 psi. Thus the regulators are set to maintain a hydrogen pressure of approximately 1.70 psi greater than the product water pressure, and an oxygen pressure

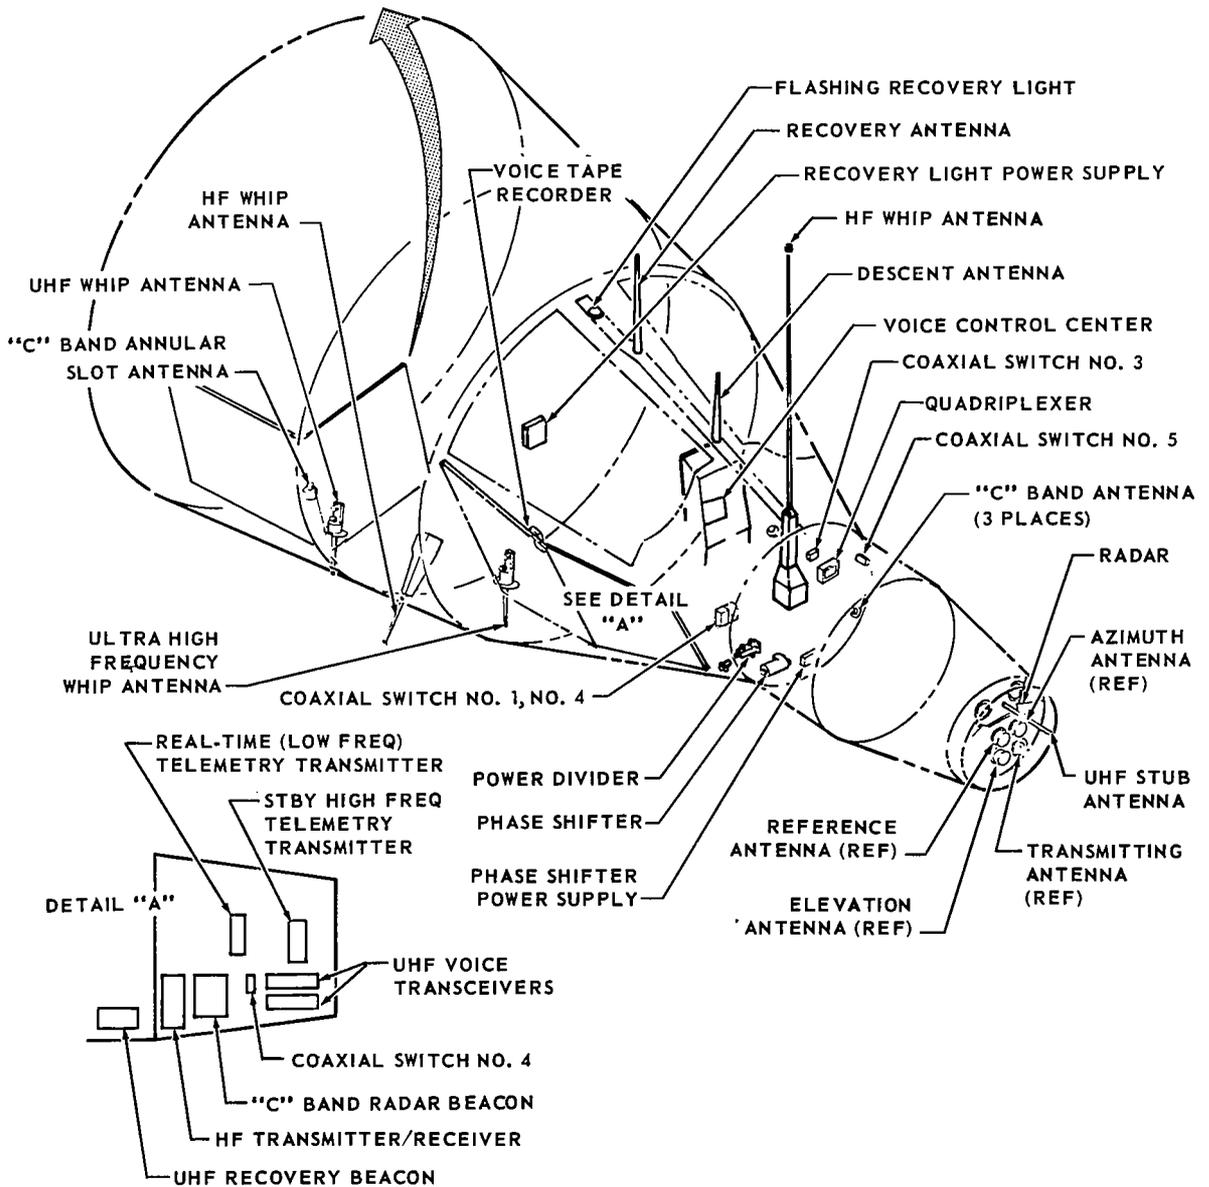
FIGURE 11 COMMUNICATION SYSTEM

The redundant UHF voice radios provide increased reliability. Only one HF radio is employed, however, because of its limited use. The UHF and HF

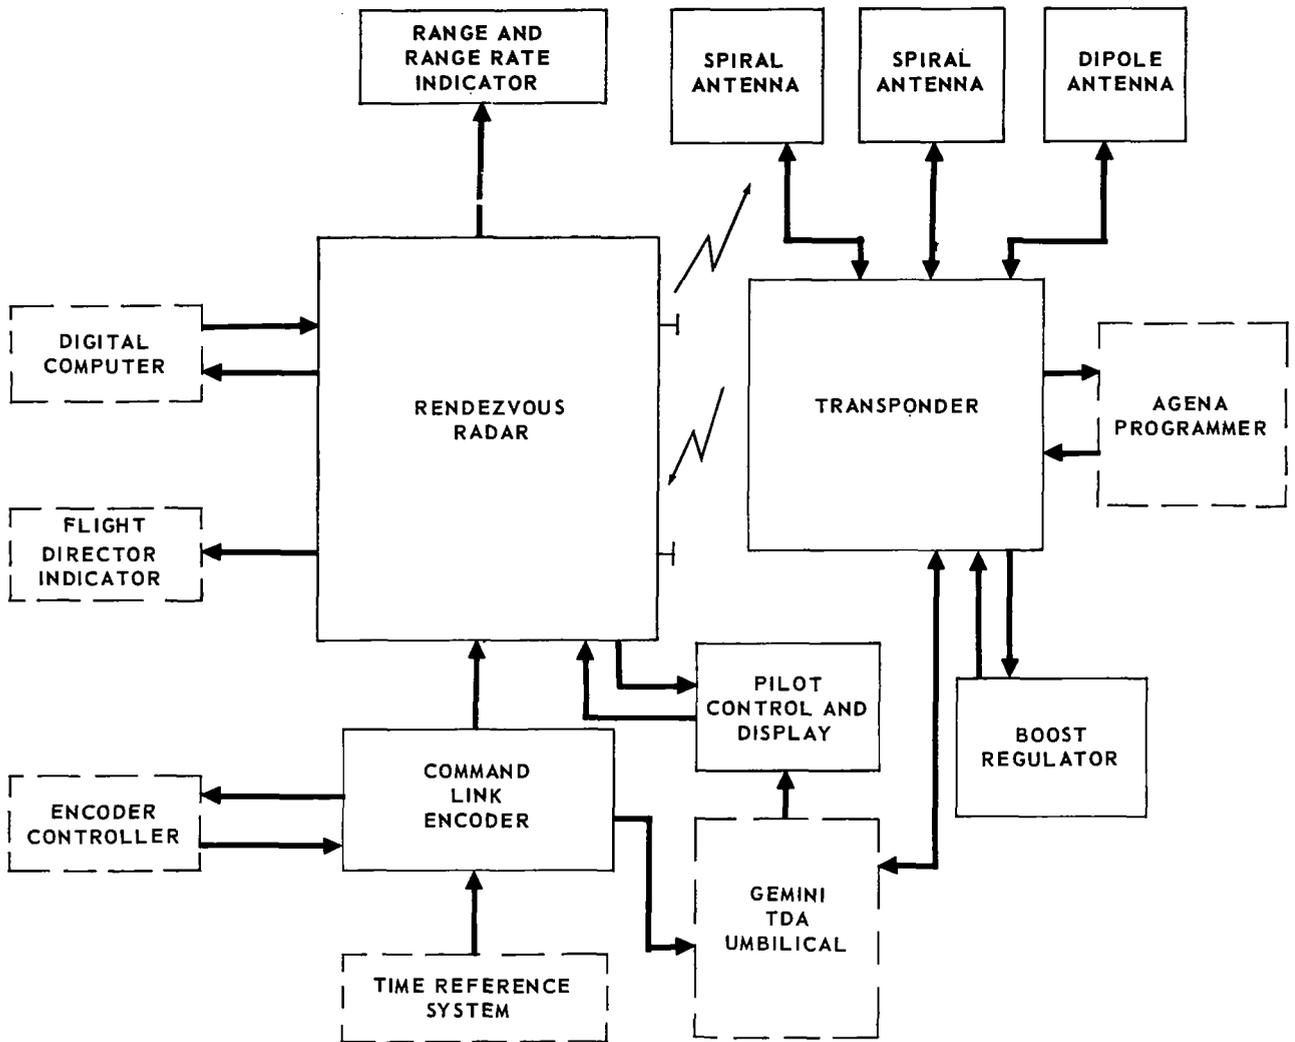
FIGURE 13 RENDEZVOUS RADAR SYSTEM

The radar utilizes the interferometer principle to determine target angle. This is accomplished by measuring the difference of phase of the return beacon

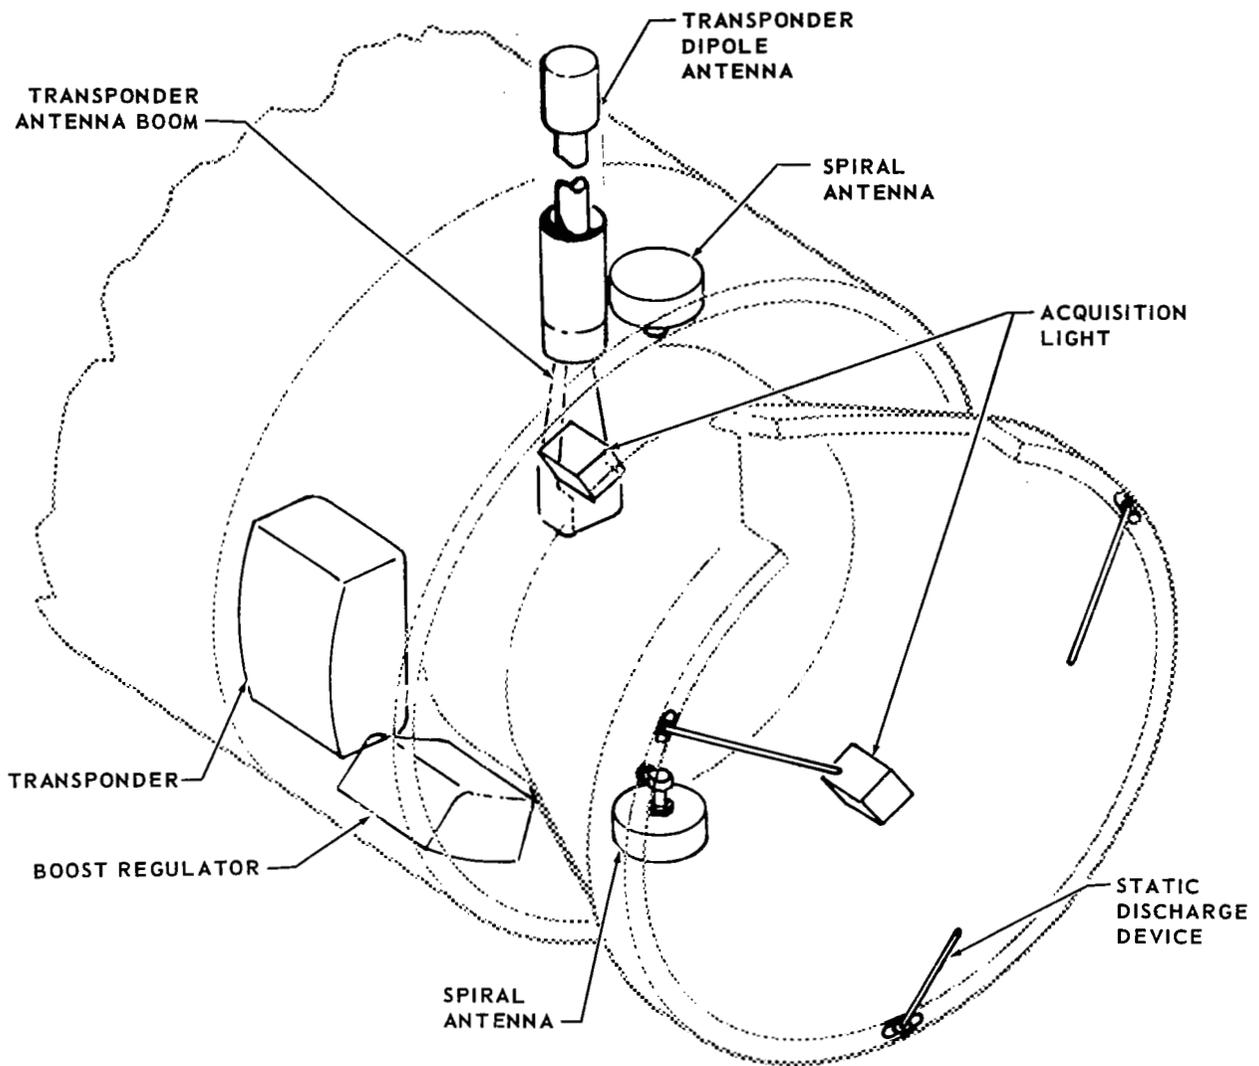
FIGURE 14 TDA ELECTRONICS SYSTEM

The transponder receives and transmits as a result of the radar interrogation either through the two spiral antennas or the dipole antenna. The radar, upon receipt of the $6.0 \mu\text{sec}$ reply pulse from the transponder, extracts range and angle information from each pulse.

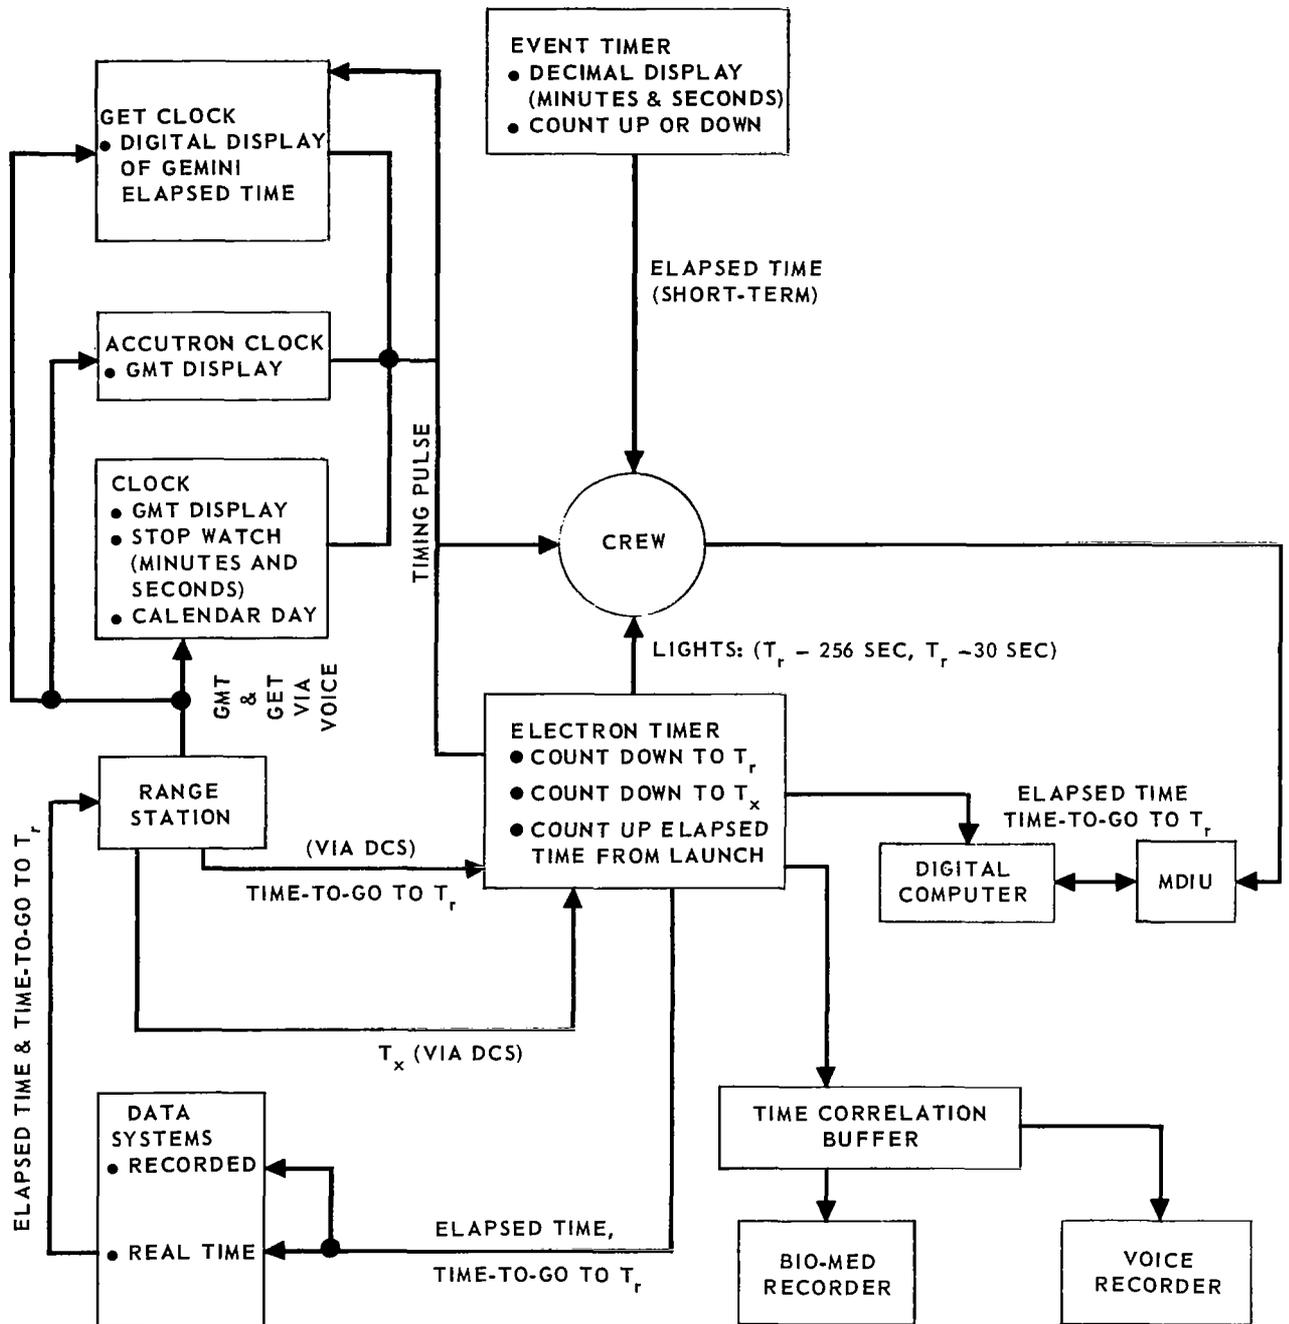
FIGURE 15 TIME REFERENCE SYSTEM FUNCTIONAL DIAGRAM

Event Timer. - The event timer provides a digital stopwatch for the crew. The display capacity of the timer is 59 min and 59 sec with a resolution of 0.2 sec. The timer will count up or down. It may be preset to a value and

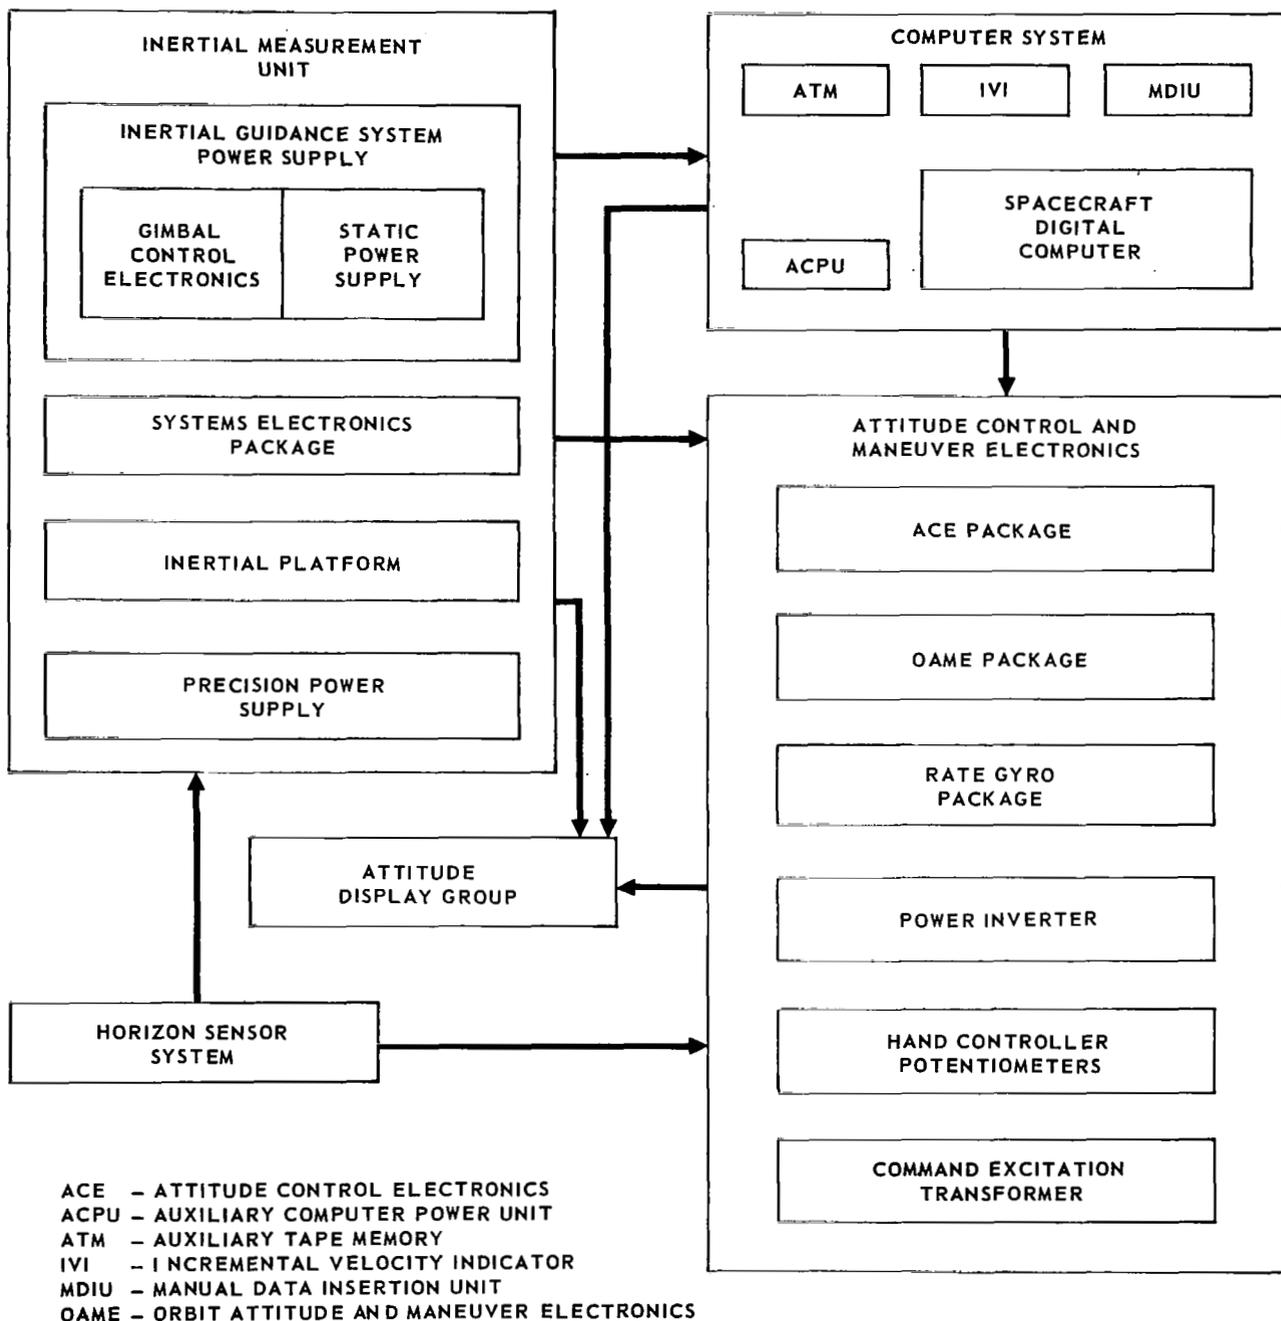
FIGURE 16 GUIDANCE AND CONTROL BLOCK DIAGRAM

1. Inertial Platform
 - a. All attitude freedom.

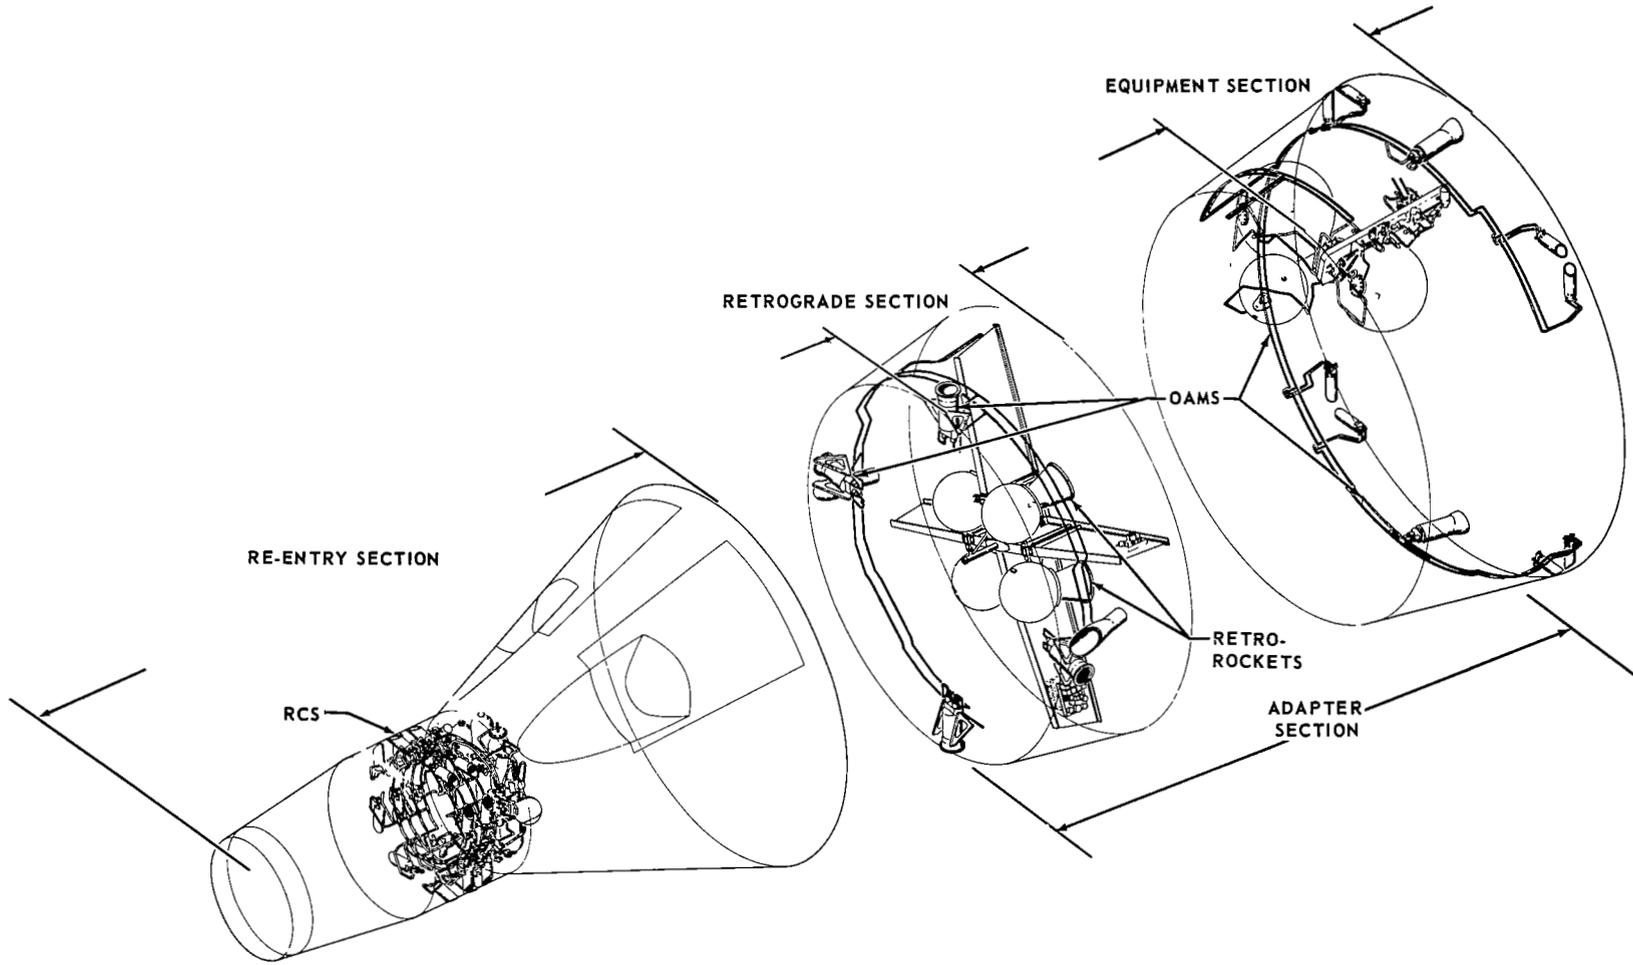
FIGURE 17 PROPULSION SYSTEMS-OAMS, RCS, RETRO LOCATION IN SPACECRAFT

C. Propellant Design Concepts - Tank propellant weight is kept at a minimum by the use of a high energy bipropellant, monomethyl hydrazine, as fuel and nitrogen tetroxide as oxidizer. These propellants are hypergolic with each other; therefore no ignition provision is required. The propellants have additional advantages: they do not require special conditioning, such as refrigeration, for storage, and they do not degrade with time. Disadvantages
