PROJECT GEMINI

A Technical Summary

by P. W. Malik and G. A. Souris

Prepared by
MCDONNELL DOUGLAS CORPORATION
St. Louis, Mo.

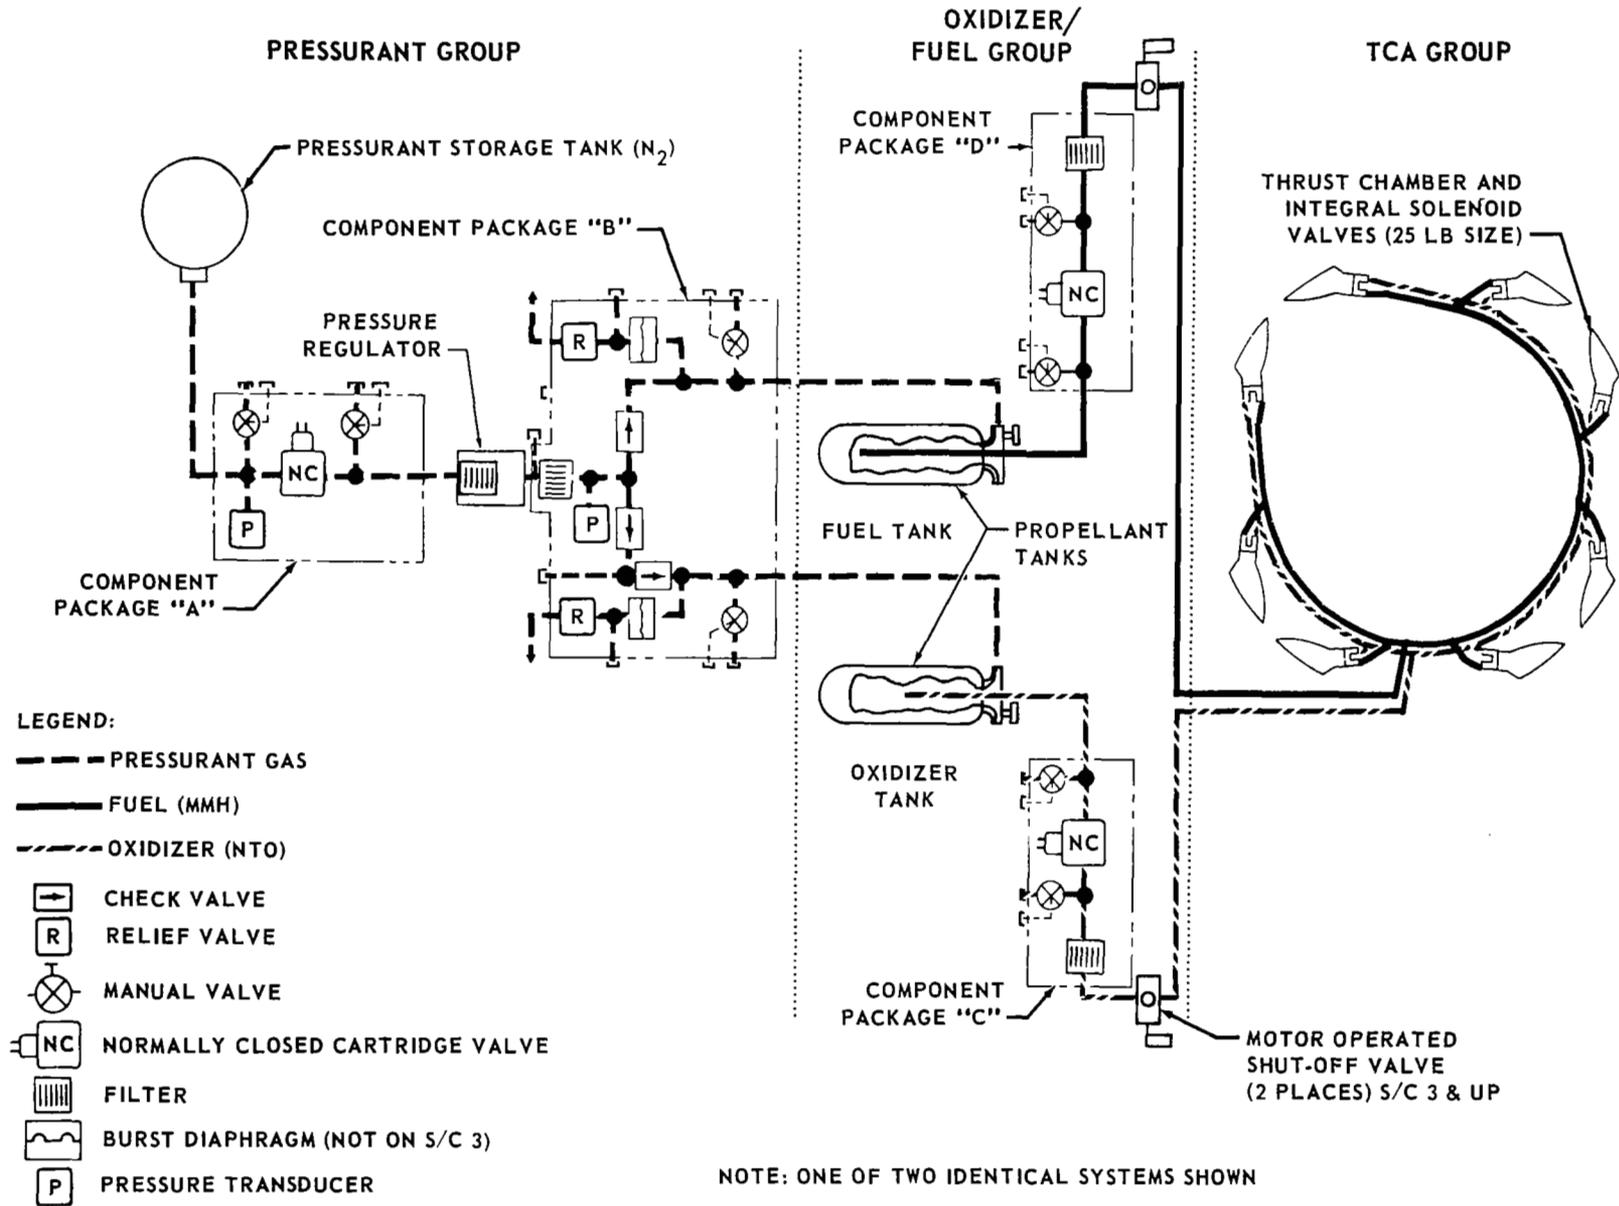
FIGURE 19 REENTRY CONTROL SYSTEM (RCS) SCHEMATIC

A. TCA Development - Early TCA development was aimed at achieving high performance (I_{sp}) and long life. Problems were encountered with delamination of the ablative chamber, throat erosion, and ablative material glass migration. These problems were not fully solved on the early spacecraft TCA, although the TCA's were fully adequate to meet the requirements of the early missions. A reconfiguration was introduced in which the mixture ratio and performance were reduced and the life span was greatly increased. At this time other improvements were introduced, such as ablative material with differently oriented wrapping and an attachment of the TCA valves to the injector, which

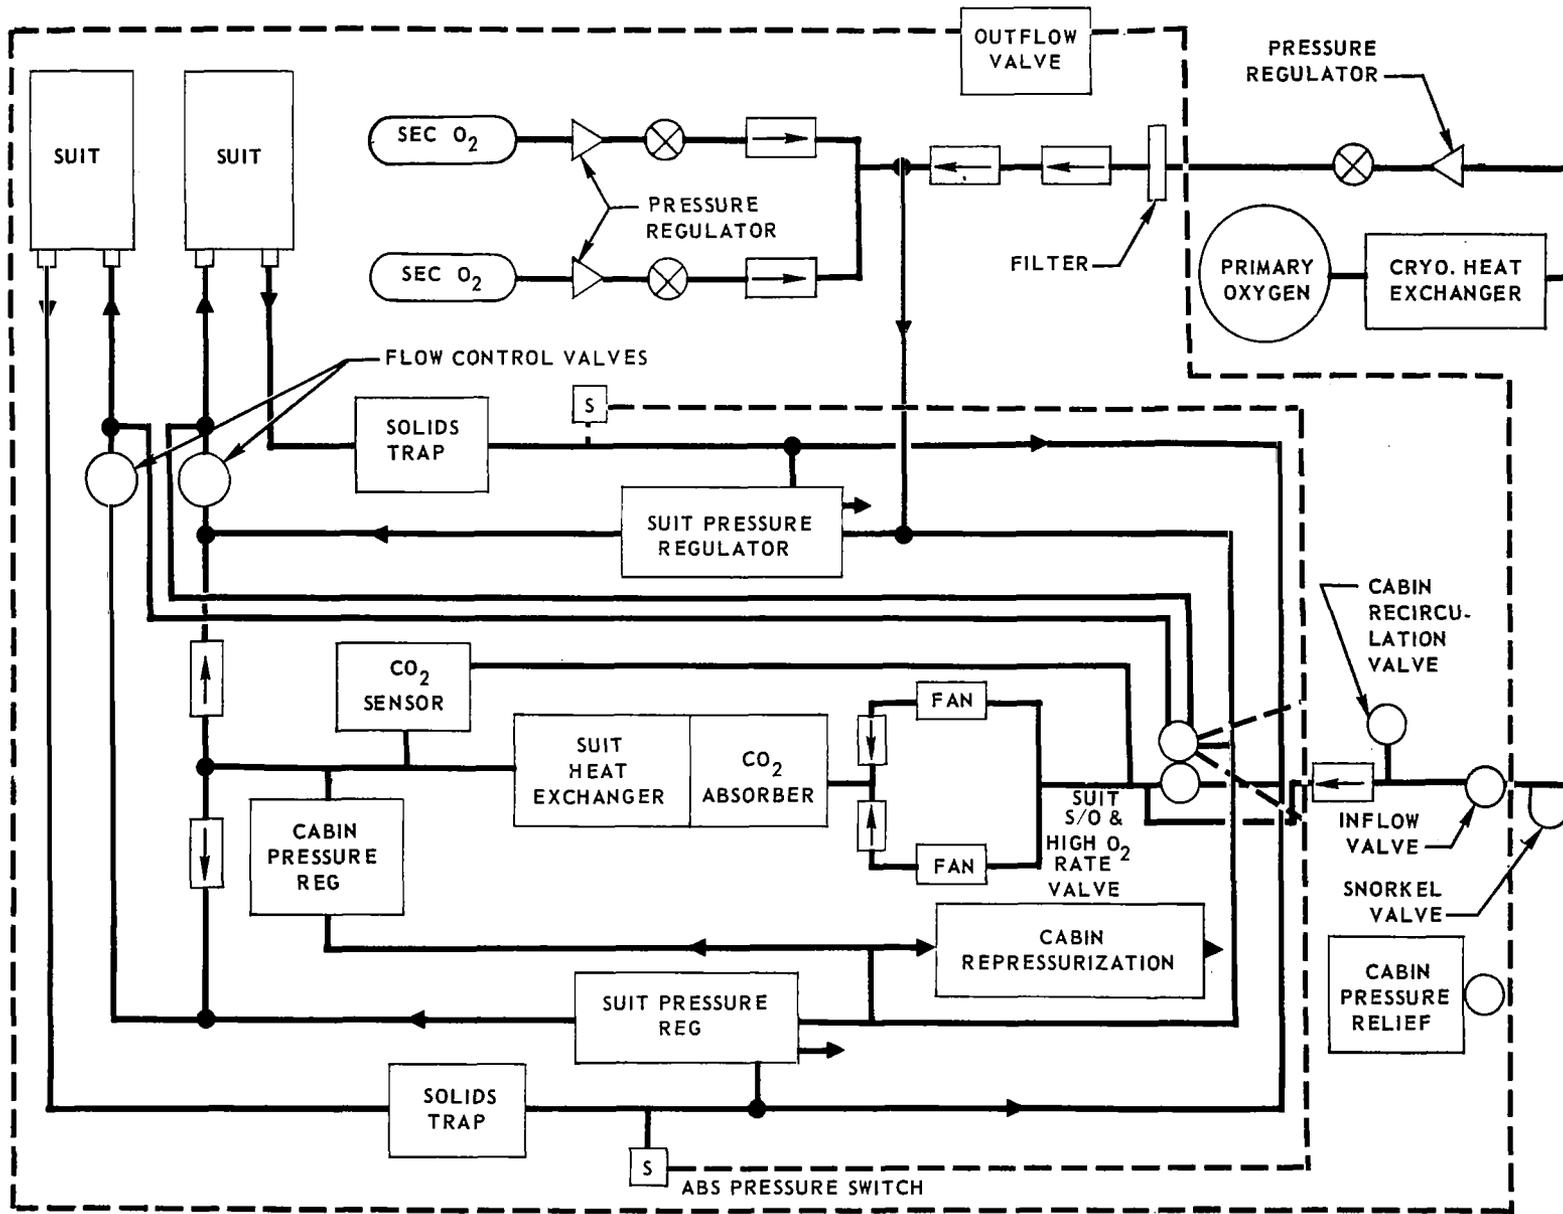
FIGURE 21 SUIT AND CABIN ATMOSPHERE CONTROL

Atmosphere Control. - A simple schematic of the suit and cabin atmospheric system is shown in Fig. 21. The primary oxygen system provides oxygen during launch and orbital flight, and the secondary oxygen system provides oxygen during retrograde and re-entry.

E. Suit pressure is maintained by the suit demand regulators.

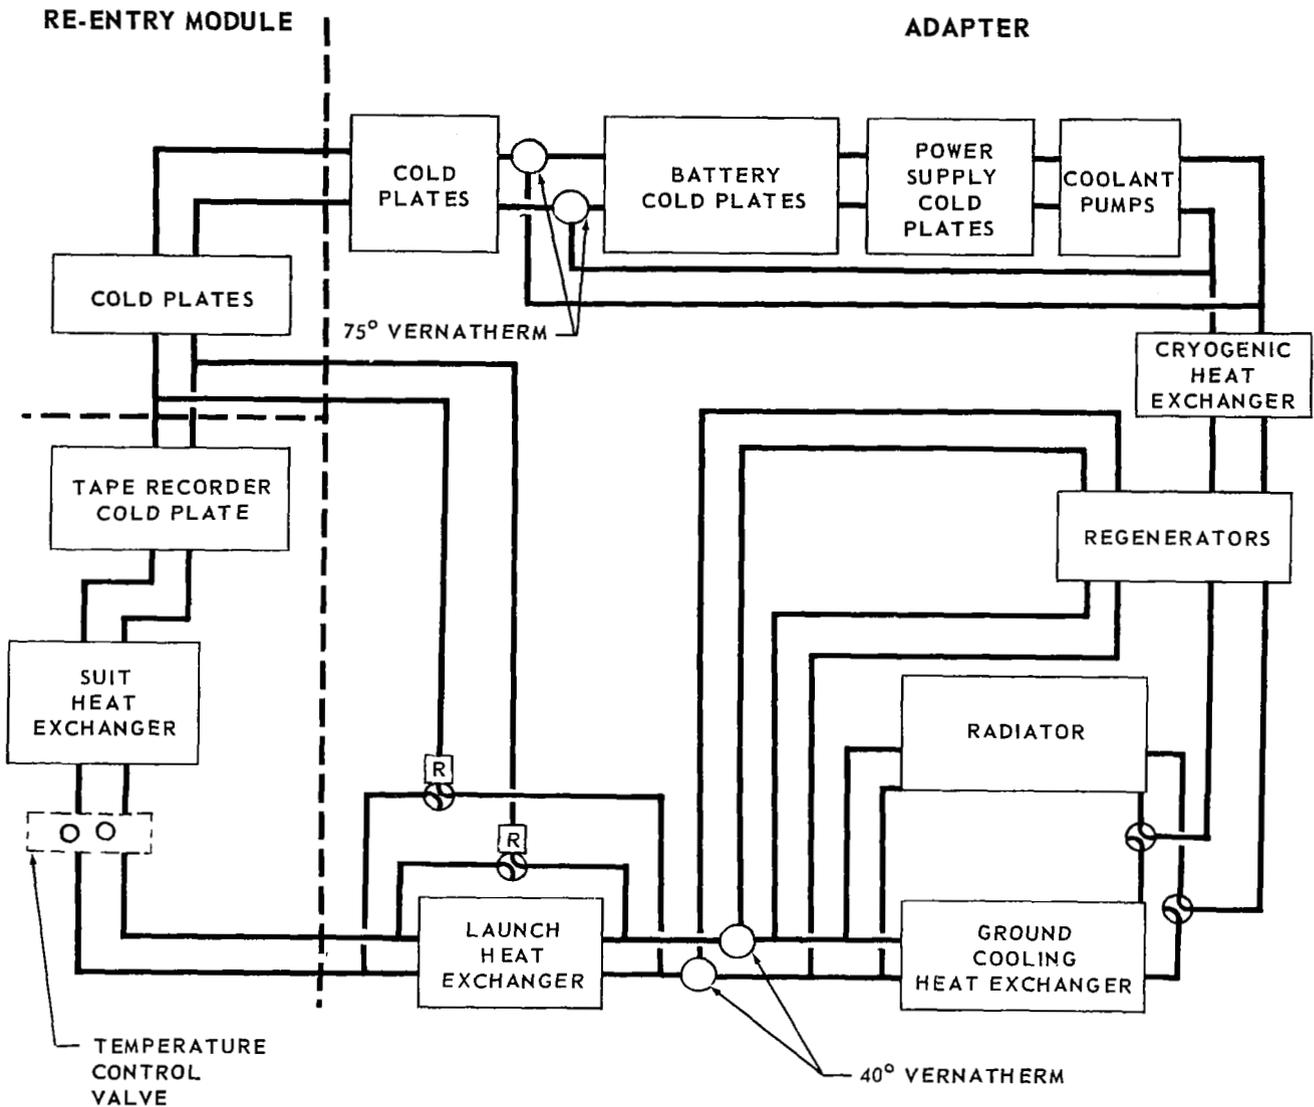
FIGURE 22 TEMPERATURE CONTROL

D. Re-entry - Heat is radiated to space by the re-entry module surfaces and is absorbed by the heat sink capacity of the re-entry module.

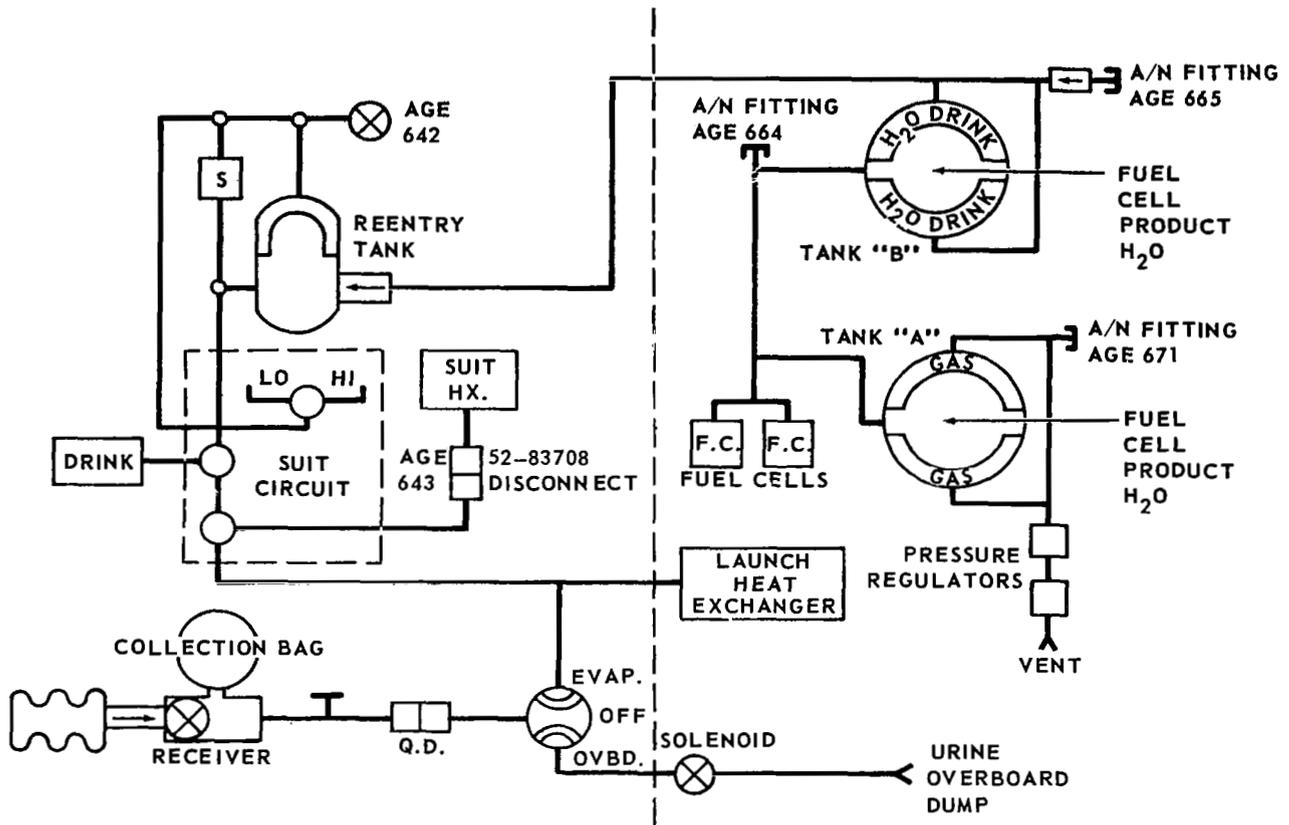
FIGURE 23 WATER MANAGEMENT SYSTEM

D. Water is supplied to the drink nozzle from the cabin tank via the drinking water tube. Water transfer pressure is provided by: (1) the adapter water tanks, (2) suit compressor outlet pressure, or (3) the biomed bulb. Water can be drunk with or without cabin pressurization.

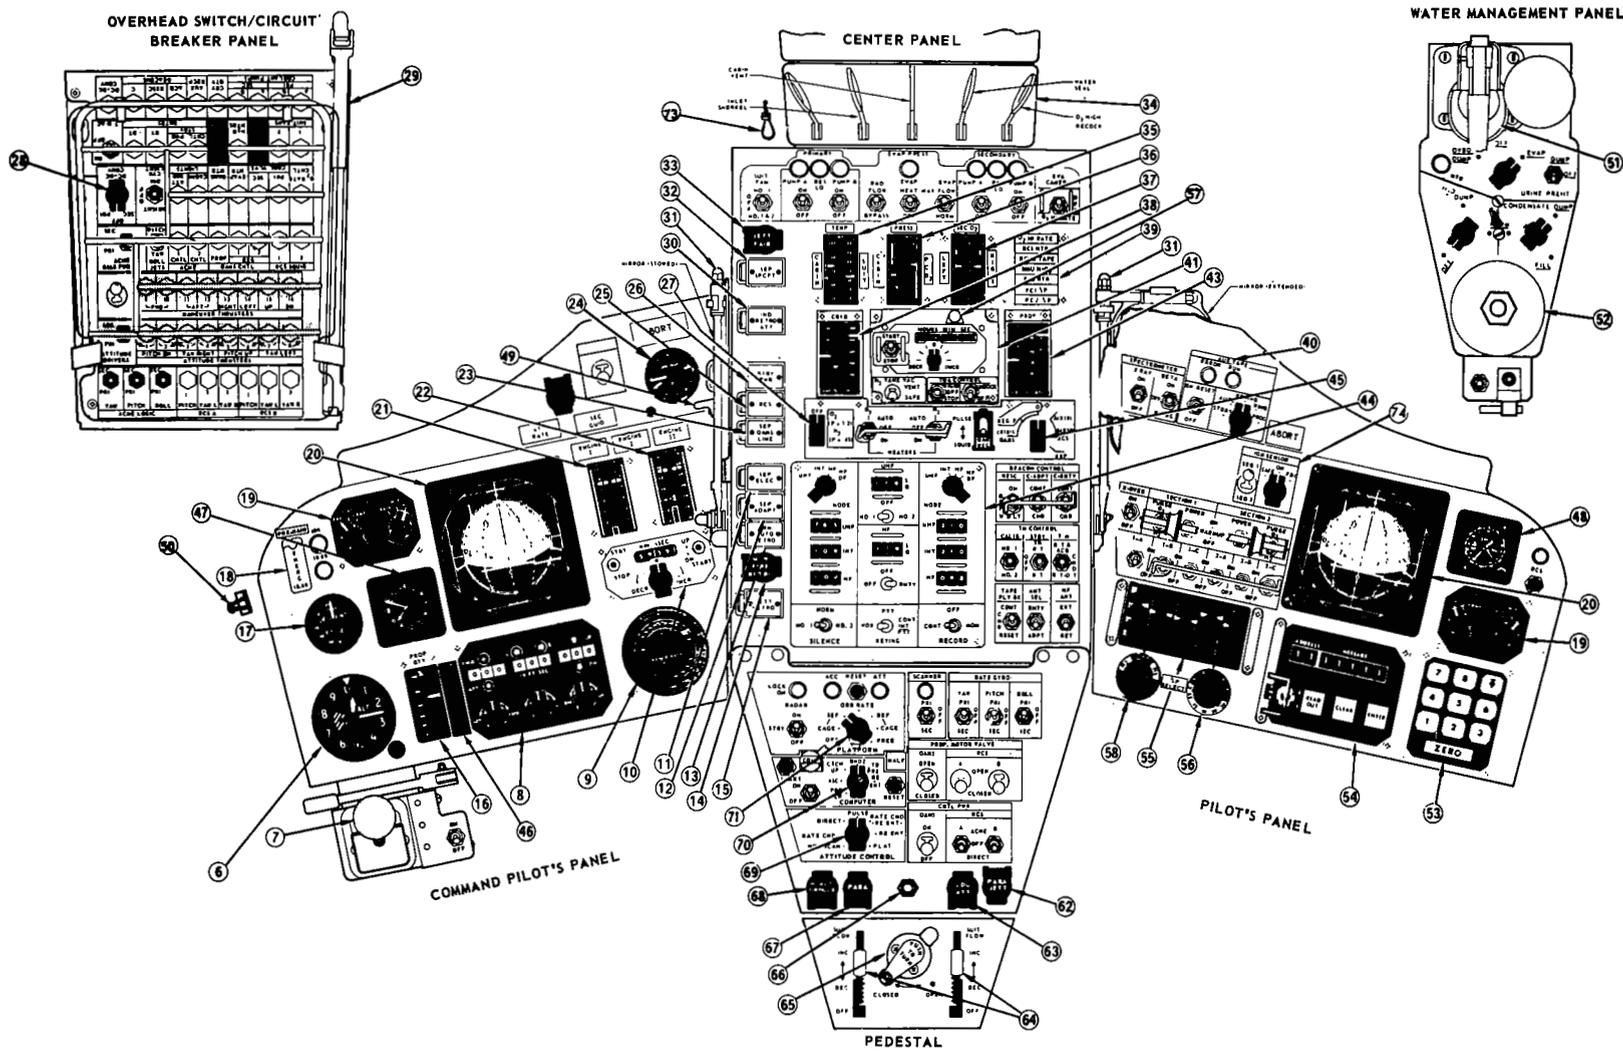
FIGURE 24 SPACECRAFT 12 CREW STATION DISPLAYS, CONTROLS AND FURNISHINGS

Several lighting trade-off studies were made for the Gemini crew station. Because of weight and power considerations, flood lighting was selected for Gemini. Since red and white lights having a dimming capacity were desired, incandescent bulbs with rheostats were selected. Additional warning and tele-panel lights were used to denote critical functions and conditions. In several cases these warning lights remained illuminated for prolonged periods, and were

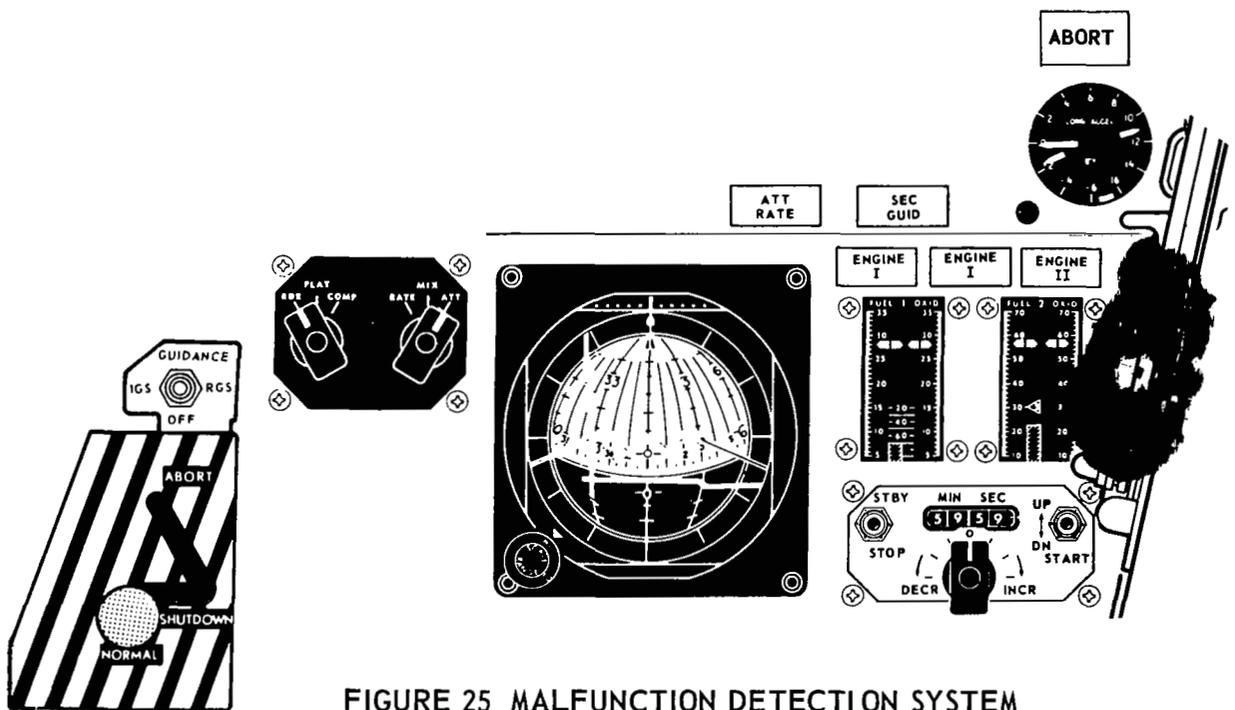
FIGURE 25 MALFUNCTION DETECTION SYSTEM

Malfunction Detection System (MDS). - The MDS design (See Fig. 25) was

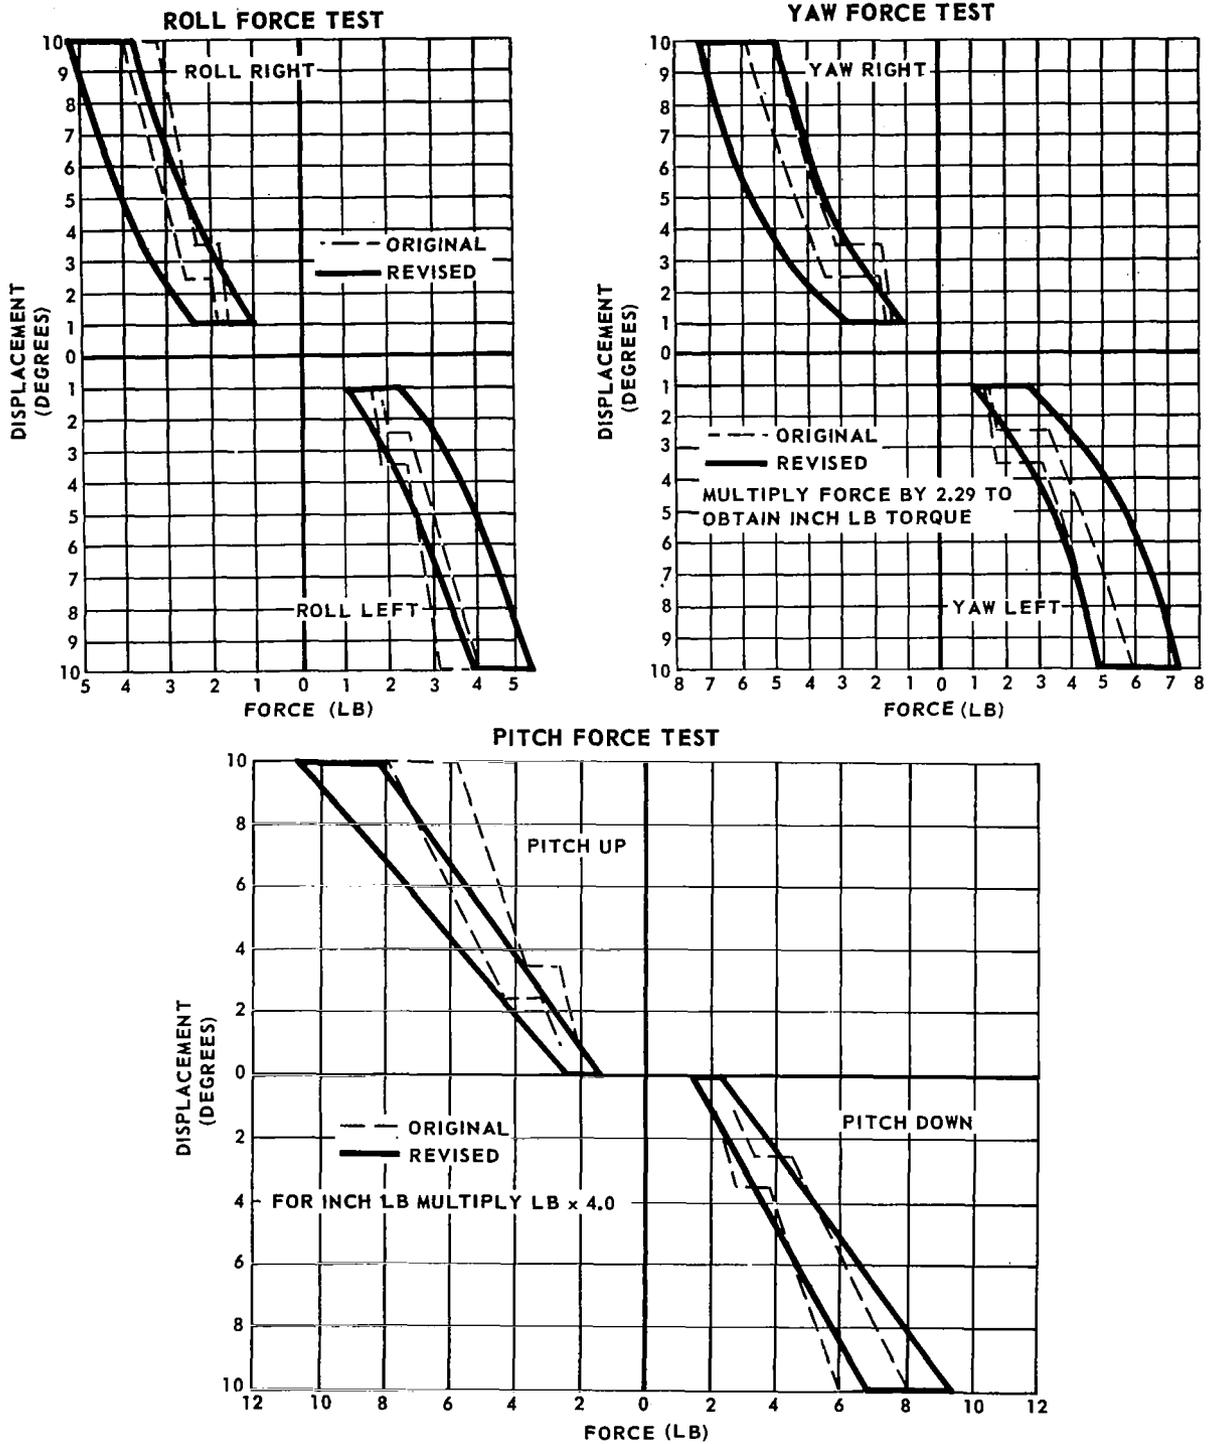
FIGURE 30 ATTITUDE HAND CONTROLLER FORCES
(ORIGINAL AND REVISED LIMITS)

C. DIRECT - Provided direct control to open thrust chamber solenoids when the attitude controller was deflected approximately 25% of full travel. (The

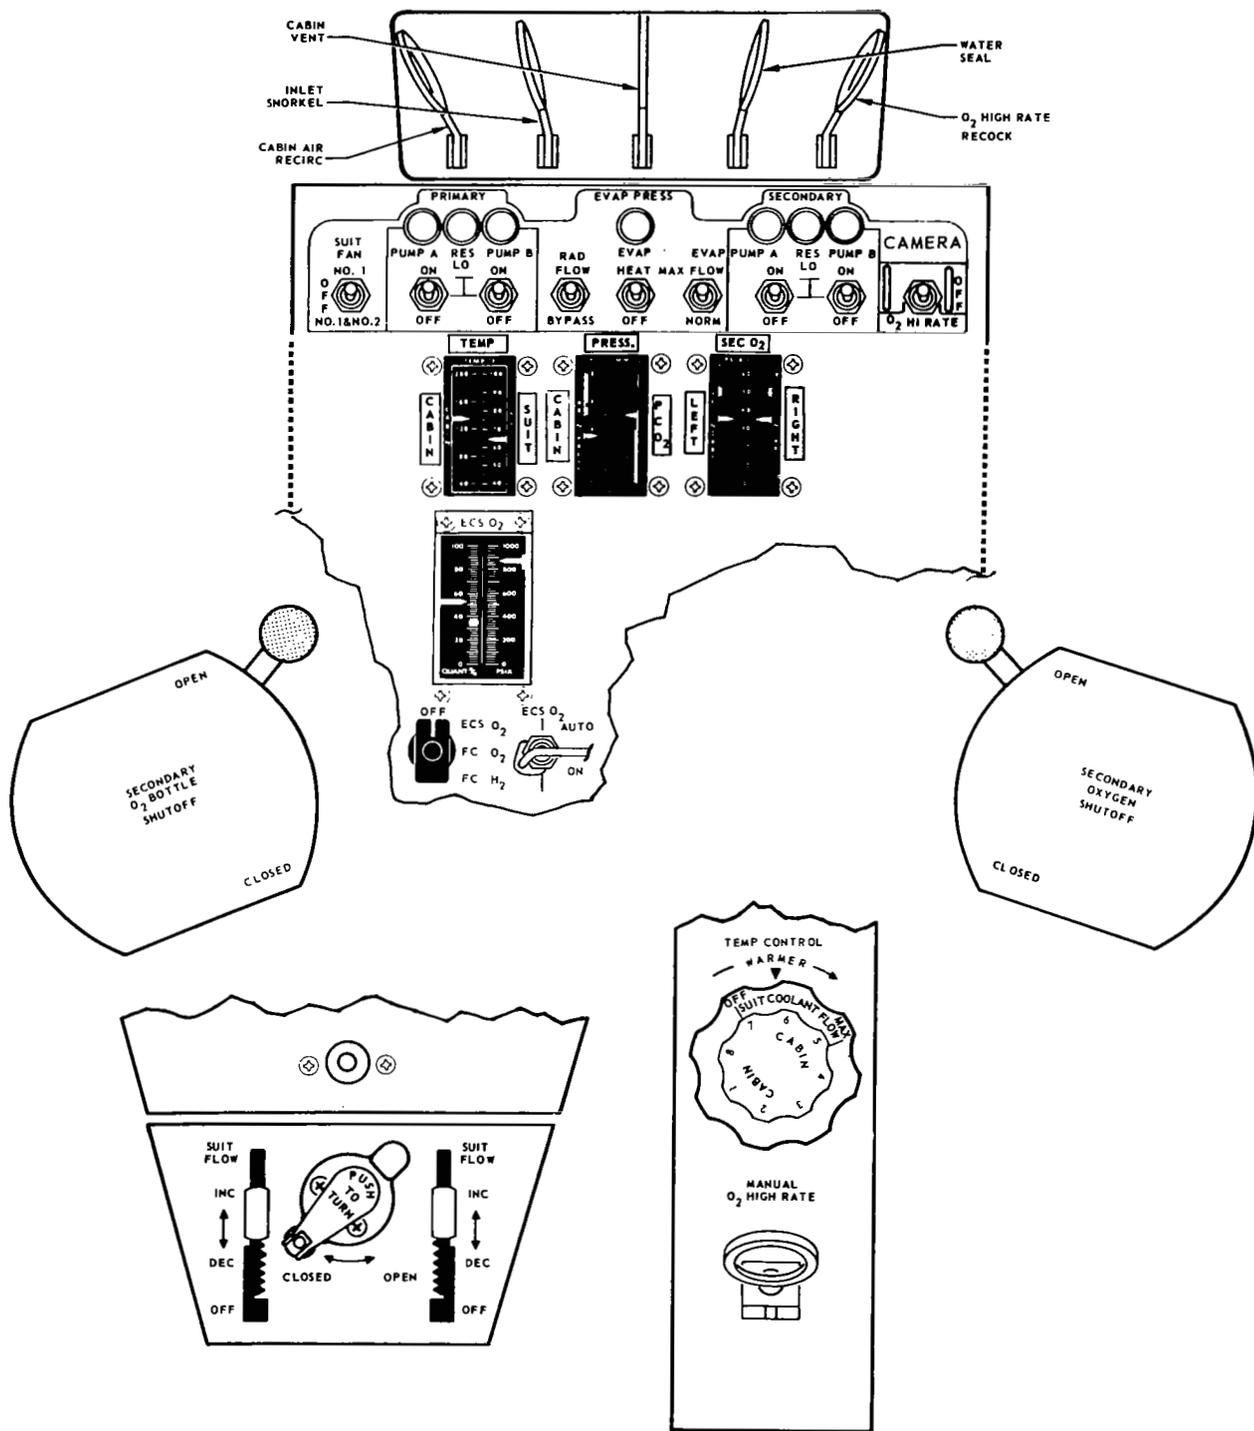
FIGURE 32 ECS CONTROLS AND DISPLAYS

Pump B in each loop also was configured to a lower flow rate to conserve power on Spacecraft 5 and up for periods of low activity and power down. All the gauges associated with the ECS remained the same on all spacecraft except that a rotary selector was added to read the cryo gauge when fuel cells were added to Spacecraft 5 and up so that fuel cell O₂ and H₂ could be read in addition to ECS O₂. A crossfeed switch was added to Spacecraft 7, 8 and 9 in order to supply ECS O₂ to the fuel cells and vice versa. This action was taken as a result of the FC O₂ cryo heater failure on Spacecraft 5. Spacecraft 10 and up had only one O₂ supply for both ECS and fuel cells. A tube cutter was added to the H₂ cryo vacuum bottle on Spacecraft 7 and up to improve the thermal characteristics. This cutter was activated by the cross-feed switch with the experiments bus armed but was labeled separately on

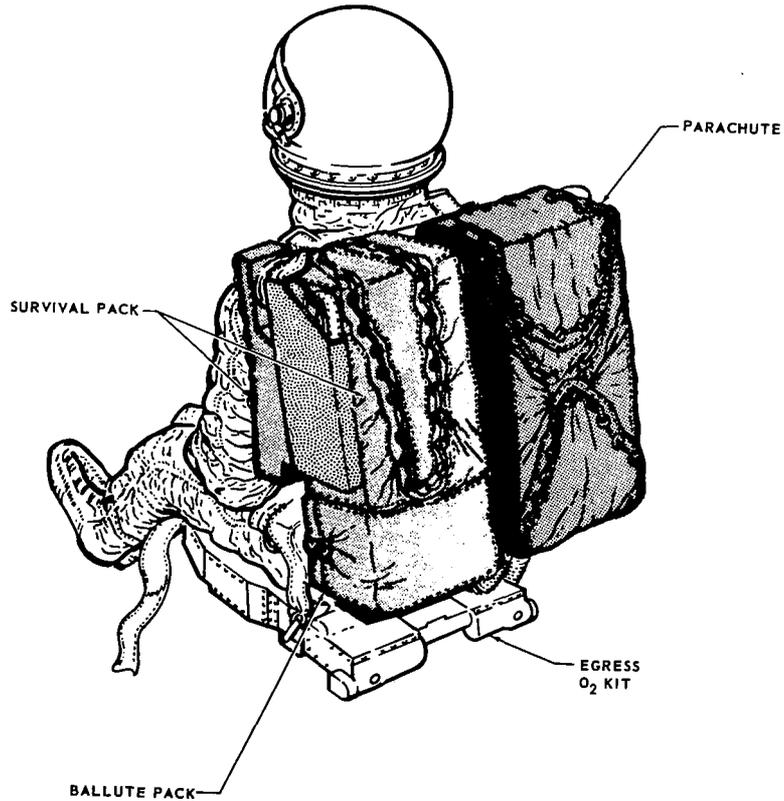
FIGURE 37 BACKBOARD/EGRESS KIT ARRANGEMENT

The survival kit is pictured on Fig. 37 and 38.

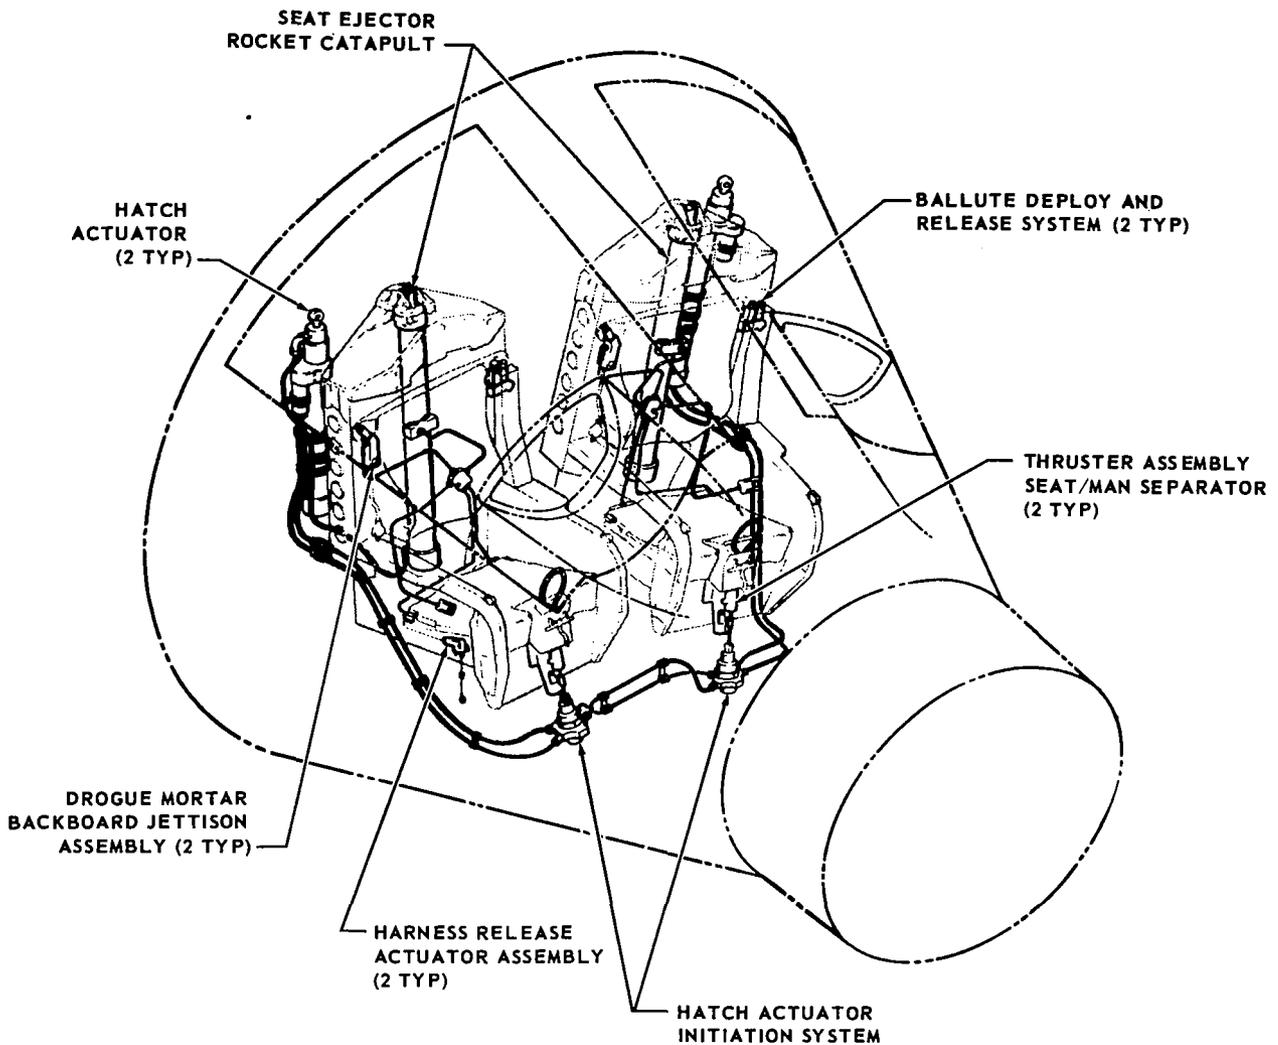
FIGURE 39 EJECTION SEAT SYSTEM AND DEVICES

The basic location and arrangement/configuration of the ejection system are shown in Fig. 39. The crew members are seated side by side, faced toward the small end of the re-entry module. Each seat is canted 12 degrees outboard

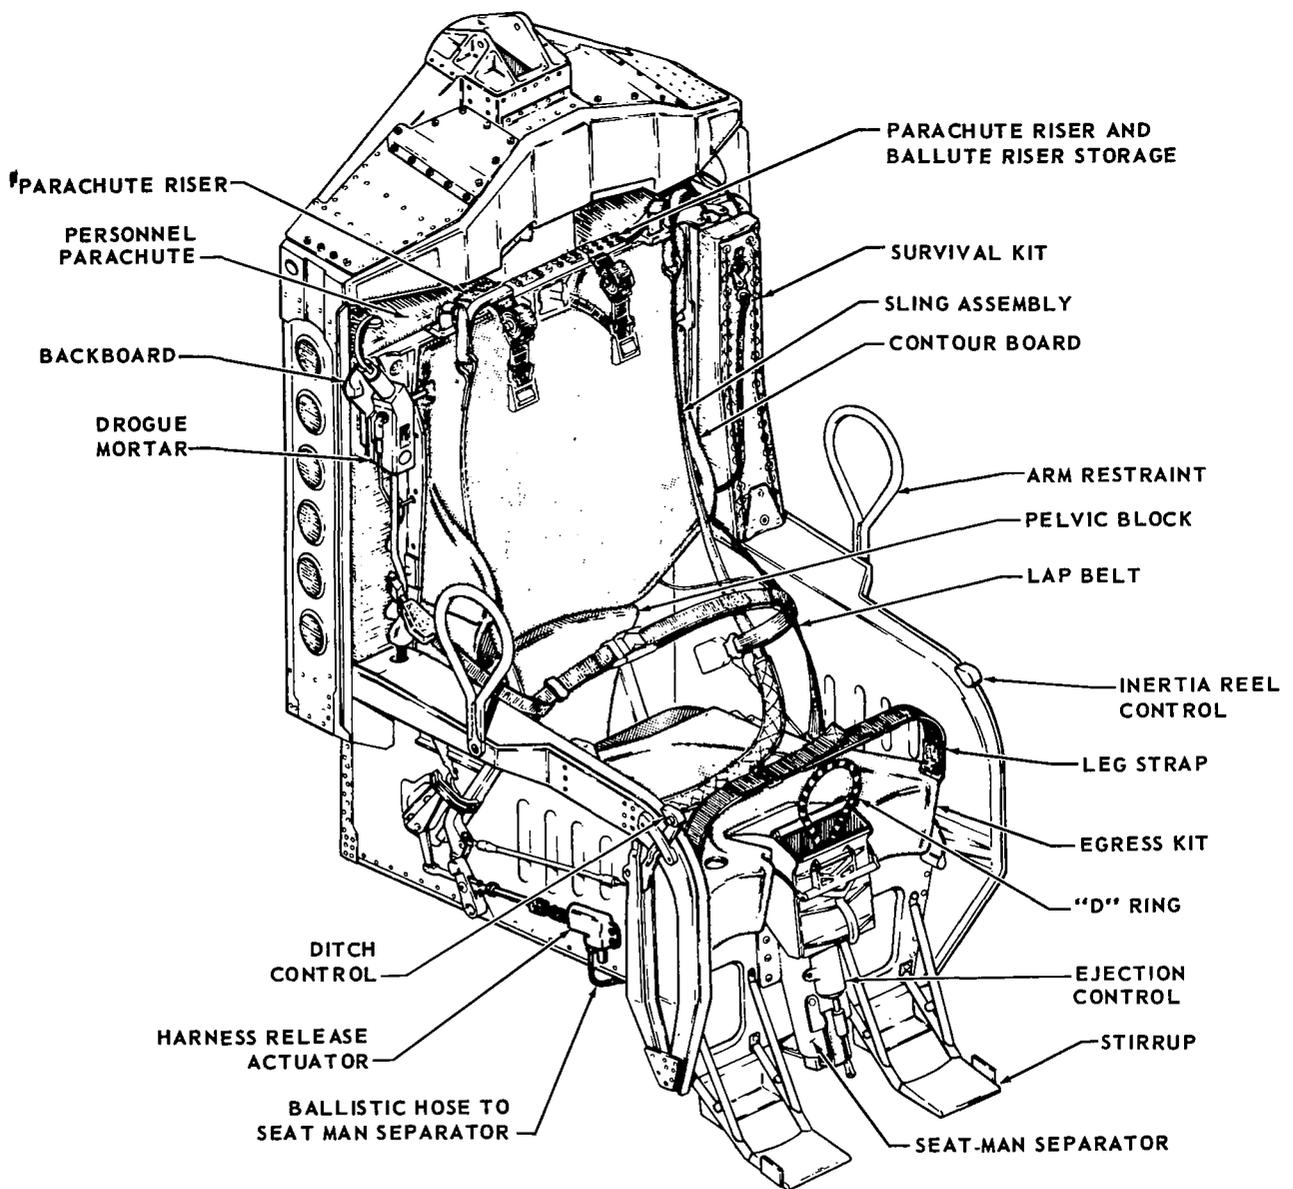
FIGURE 40 EJECTION SEAT ASSEMBLY

Ejection Seat. - The ejection seat as shown in Fig. 40 is basically a sheet metal structure built on a torque box frame principle. The seat is mounted in the spacecraft on T-type rails attached to the large pressure bulkhead and held in position by a single bolt at the top of the seat back where it attaches to the rocket catapult. The seat structure includes a seat back, seat pan, side panel, arm rests, padded headrest, stirrups, stowable arm restraints and seat slider blocks. Attached to the seat structure is the equipment required to separate the man from his seat. This includes the ejection control mechanism, seat-man separator thruster, seat-man

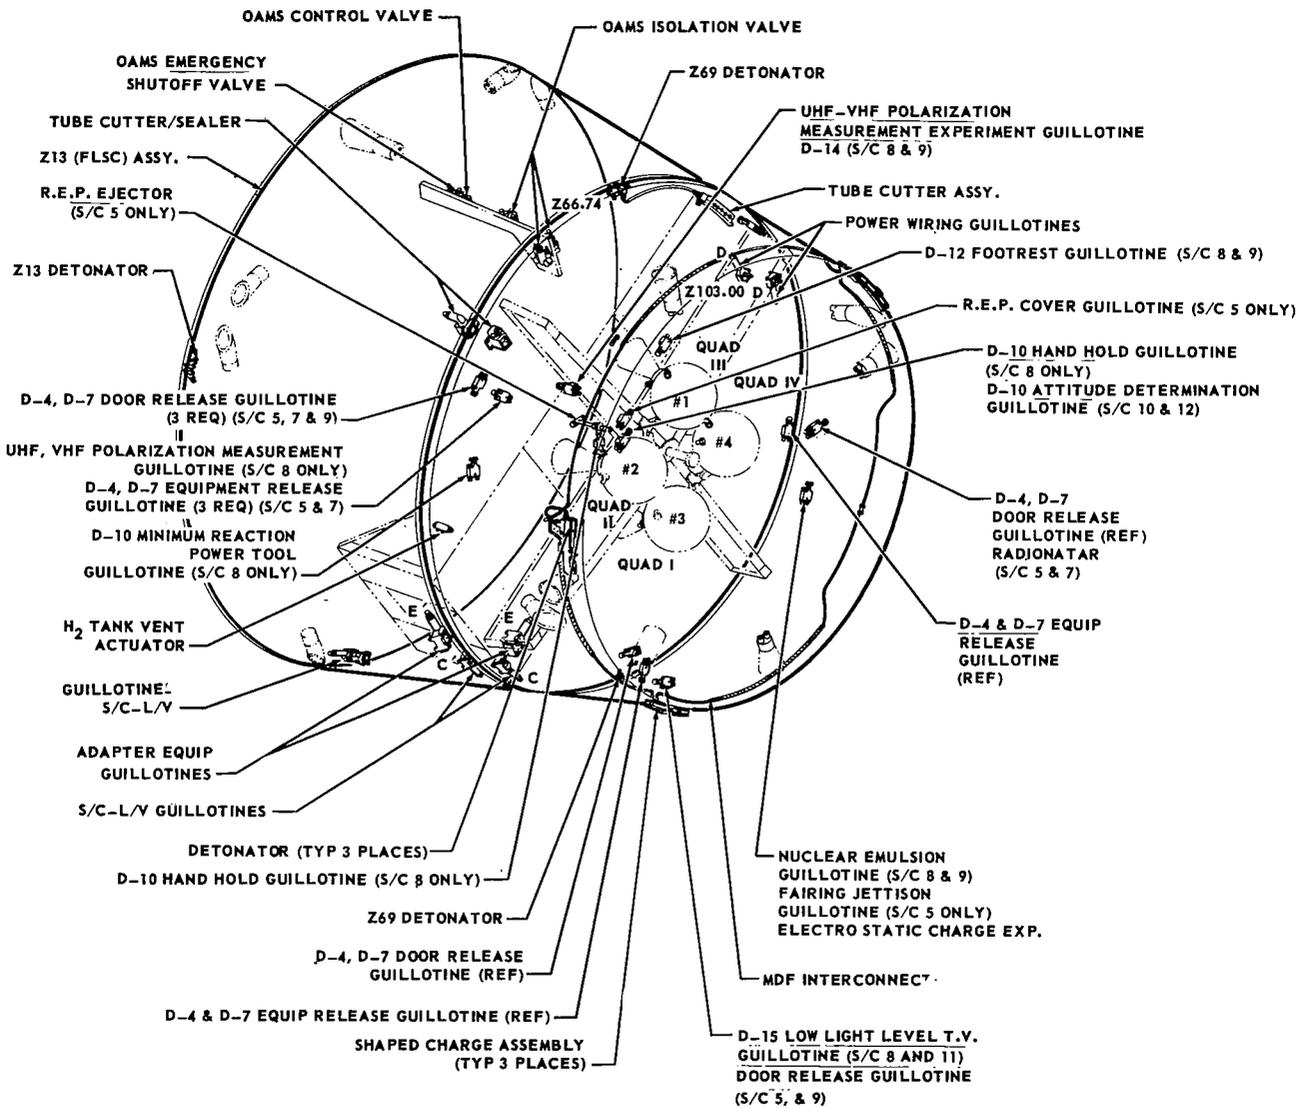
FIGURE 45 SPACECRAFT PYROTECHNIC DEVICES

The heat-sensitive mix, which encases the bridgewire, ignites when electricity passes through the bridgewire. This in turn initiates the next explosive element in the train of explosives. The number and type of explosive elements in the train from the ignition mix to the final output charge vary with requirements. Cartridges are designed with an energy output

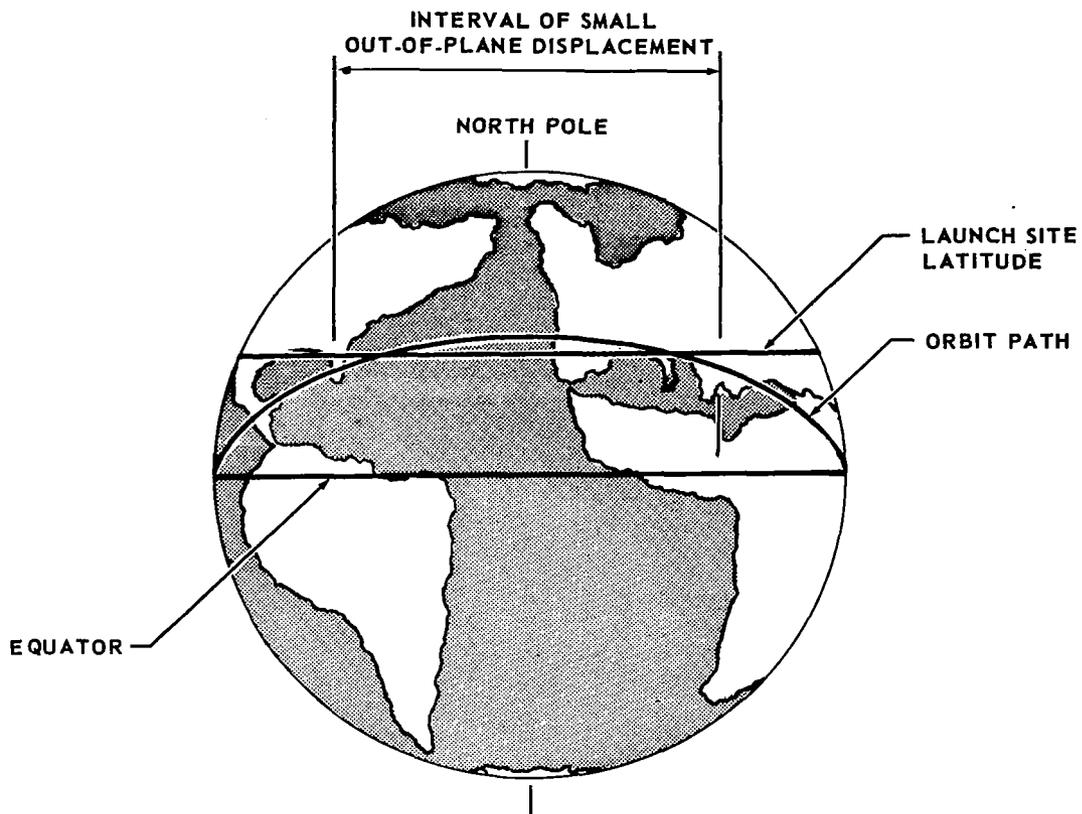
FIGURE 47 ORBIT PATH RELATIVE TO LAUNCH SITE LATITUDE

The target orbit altitude also affects the launch window. Since the altitude specifies the period of the orbit, it determines the points in the plane window where the in-plane phasing is equal to the desired value. The range of acceptable phasing values determines the phasing windows or "panes" within the launch window as shown in Fig. 48. A desirable situation would be to achieve a zero phasing error at the same time that the out-of-plane displacement is zero on several consecutive days. While this can be achieved, the required altitudes are either so low that lifetime constraints are violated or so high that the launch vehicle capabilities are exceeded. An altitude of 161 nautical miles was finally chosen since it provides a phasing

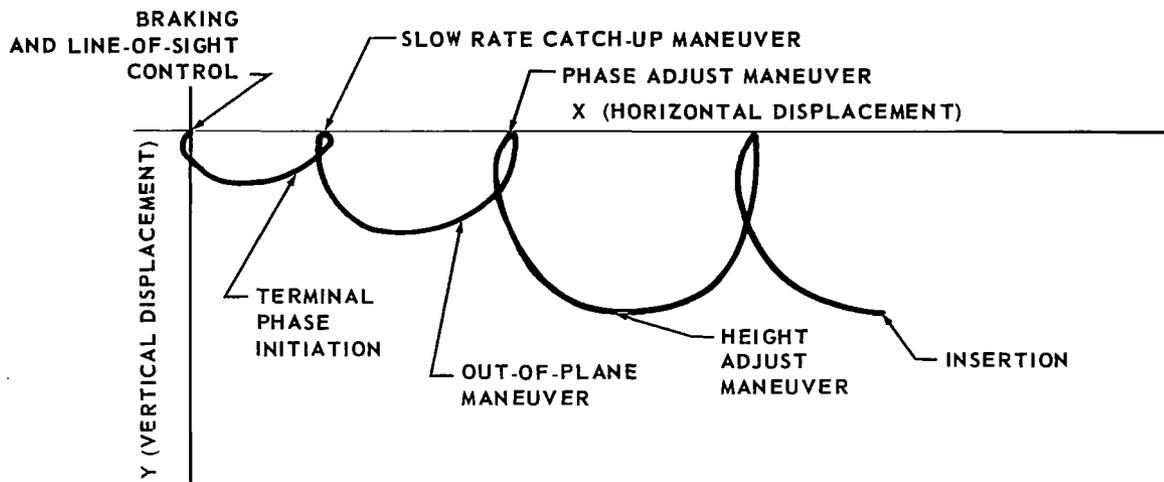
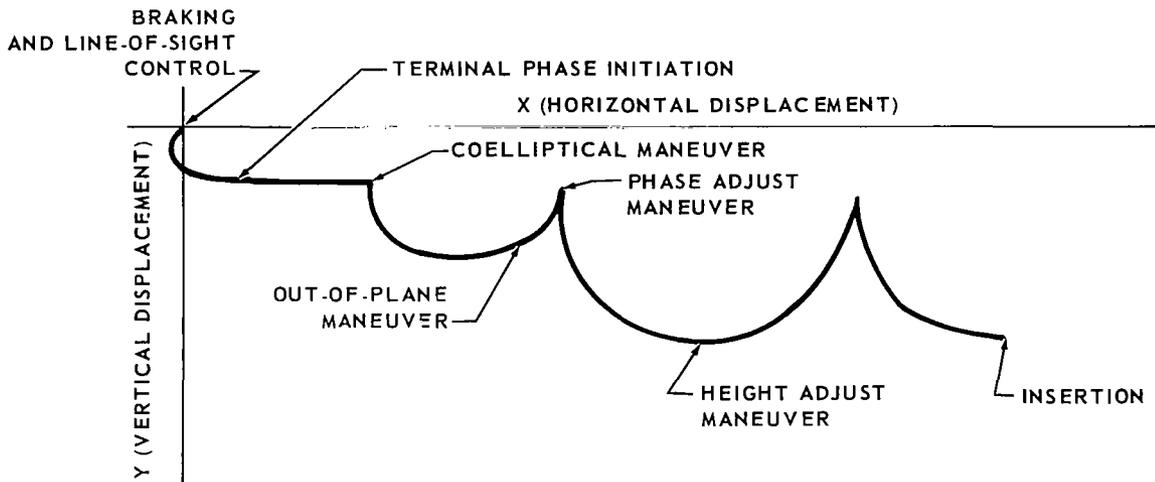
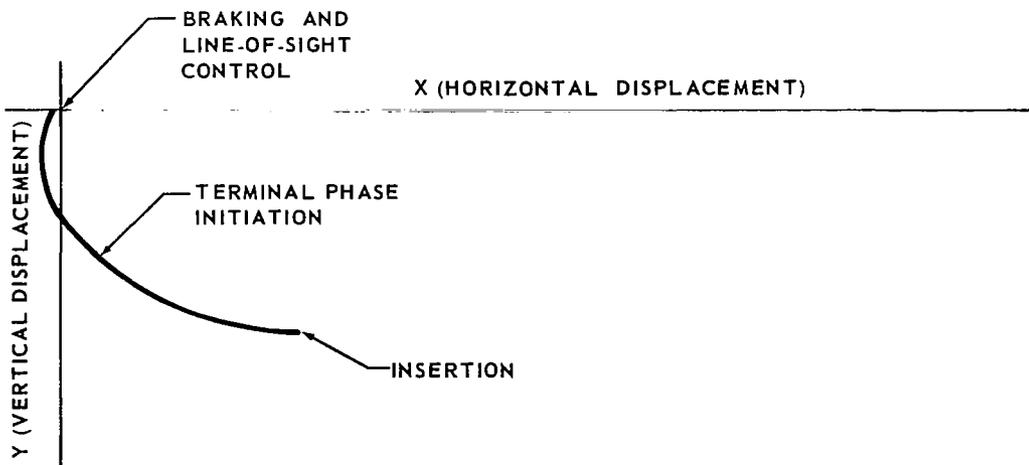
FIGURE 51 CONCEPTS PROPOSED FOR THE FIRST GEMINI RENDEZVOUS

The manner in which these constraints were involved in the trajectory planning was illustrated by the evolution of the first Gemini rendezvous plan. The first step in this evolution was the selection of a few concepts for achieving the desired objectives. As shown in Fig. 51, three different

A. The first apogee rendezvous was eliminated from consideration because of the relatively high expected propellant consumption.
