PROJECT GEMINI

A Technical Summary

by P. W. Malik and G. A. Souris

Prepared by
MCDONNELL DOUGLAS CORPORATION
St. Louis, Mo.

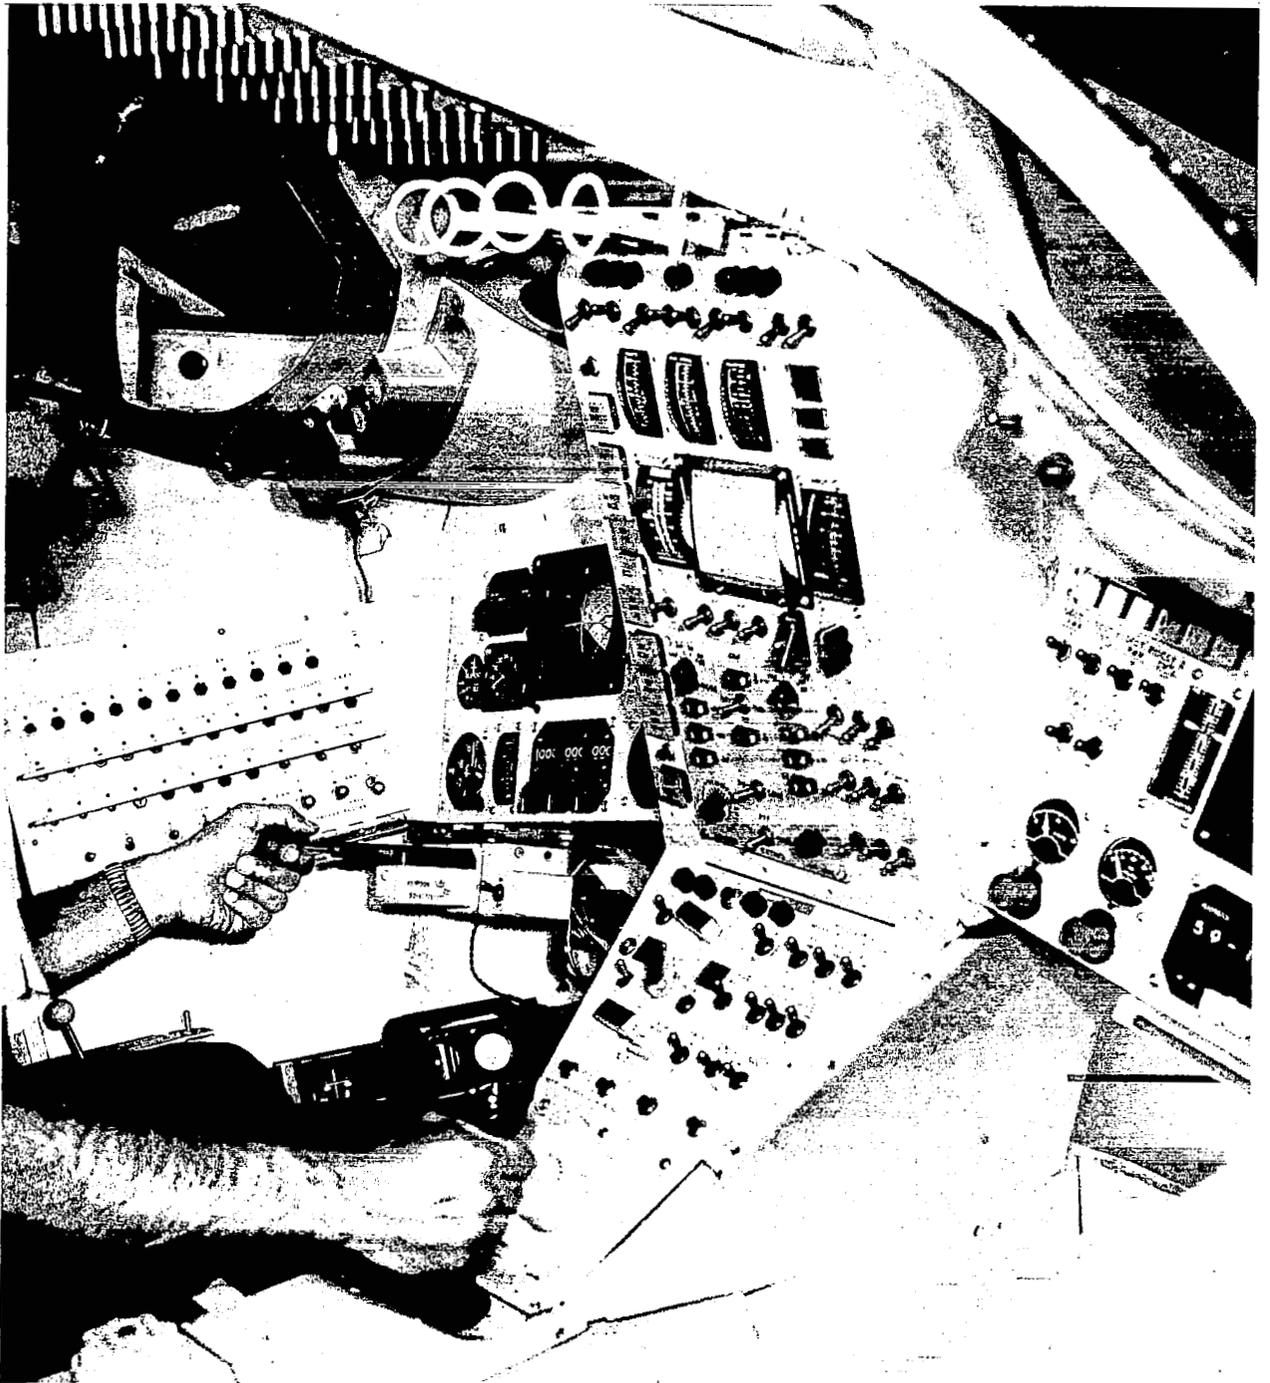
FIGURE 52 HYBRID SIMULATOR CREW STATION

DIGITAL: CDC 3200 EAI DOS CONVERT: ADAGE (2) ANALOG: EAI 231 EAI 131	CREW STATION II AGENA STATUS PANEL.	SEE SECTION 4.6.1.3 USED ON SPACECRAFT 9, 10 AND 11.
DIGITAL: CDC 3200 CONVERT: EAI DOS DIGITAL: CDC 3200 CONVERT: ADAGE 770 (2) EAI DOS ANALOG: EAI 231 SAME AS 8b. SAME AS 8c.	CREW STATION II CREW STATION II CREW STATION II STAR PLANETARIUM SAME AS 8c	SEE SECTION 4.6.1.4 USED FOR SPACECRAFT 8. USED FOR PRELIMINARY SPACECRAFT 10 WORK. USED FOR SPACECRAFT 10. DEVELOPED FOR SPACE- CRAFT II AND USED FOR SPACECRAFT 12.

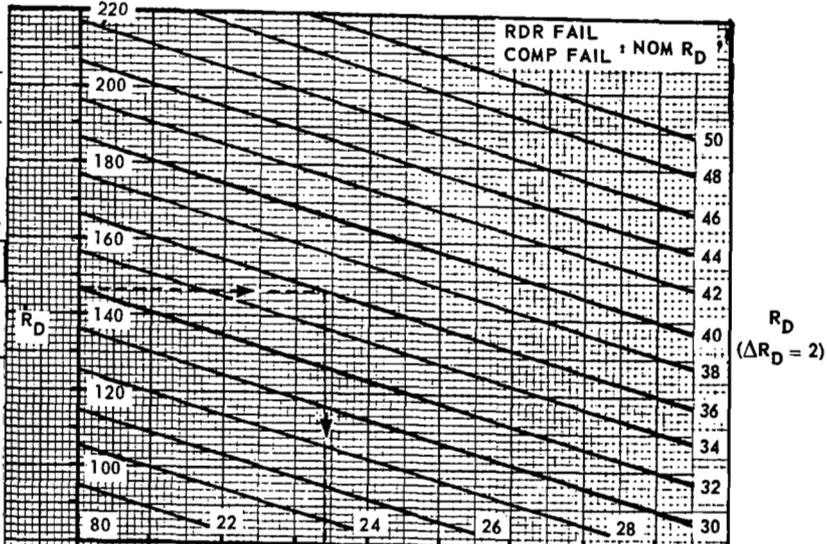
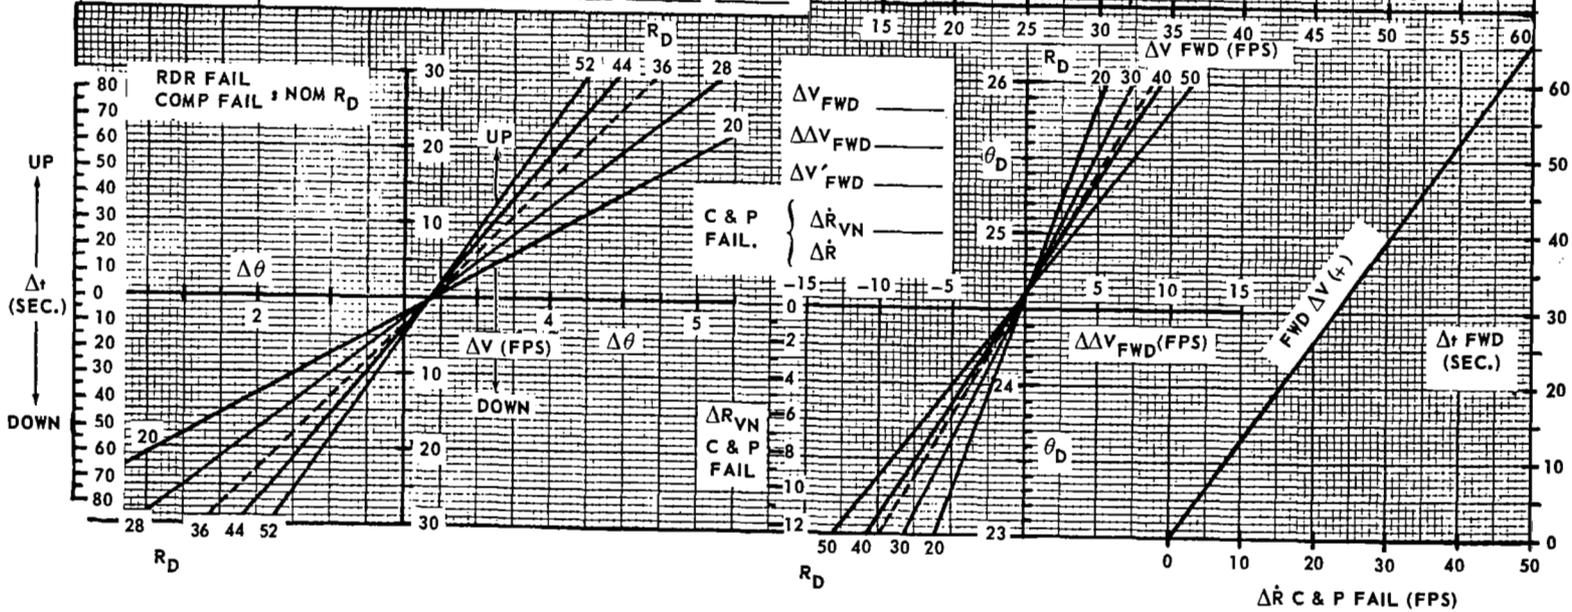
FIGURE 54 TERMINAL PHASE INITIATION

PT TIME	θ (96)	R (69)	R (35)	CL/R/C NOM	PLT
B	<input type="text"/>	.	.	θ_D	24.6 α_D
+ 1:40	21.4	41.00	149.	$-\theta_B$	21.4 $-\alpha_B$
C	<input type="text"/>	.	.	$\Delta\theta$	3.2
+ 1:40	22.9	38.55	148.		10.1 $-\Delta\alpha$
D	<input type="text"/>	<input type="text"/>	<input type="text"/>		$\Delta\theta$
+ 2:00	24.6	36.14	146.		
I	<input type="text"/>	G IVI ΔV ΔT USED			
+ 1:40		F			
SET	<input type="text"/>	U-D			
		L-R

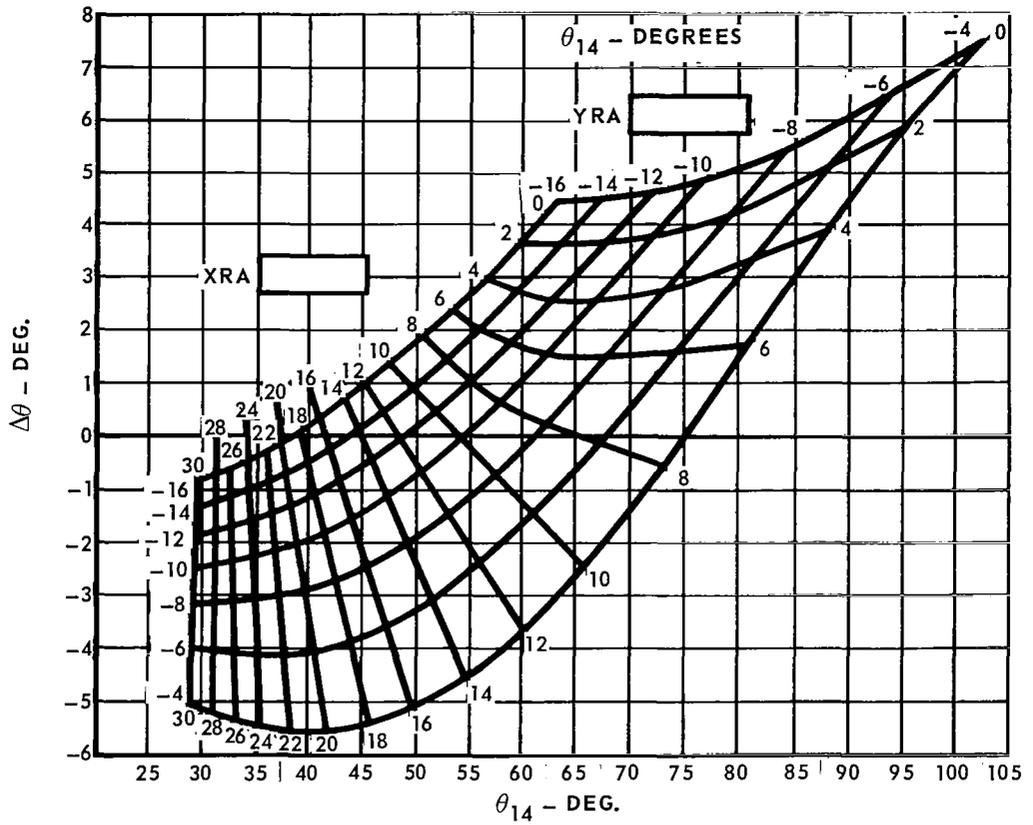
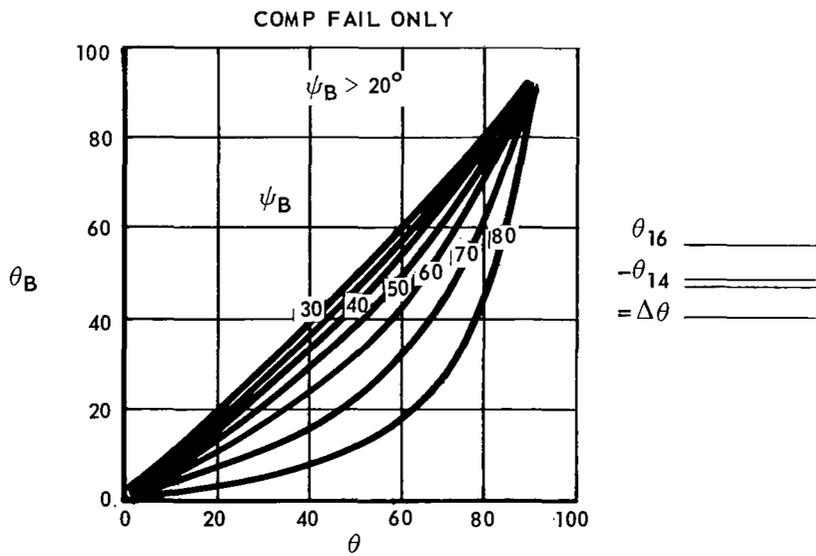
FIGURE 55 $\Delta V_A = 0$ CL, R AND C FAILURE

A measure of procedures and flight chart effectiveness for Spacecraft 6 through 11 primary rendezvous missions is presented in Table 34, which provides a comparison of the closed-loop, back-up, and ground computed solutions for the TPI maneuver during the primary rendezvous. The close agreement between the closed-loop solutions and those available from the flight charts indicates that rendezvous could have been accomplished onboard with a high probability of success on any of the missions with proper ground control up to the TPI maneuver, had a closed-loop failure occurred. Due to a
